# Effects of the Line Surge on the Gamma Camera

L. David Wells

*The University of Kansas Medical Center, Kansas City, Kansas*

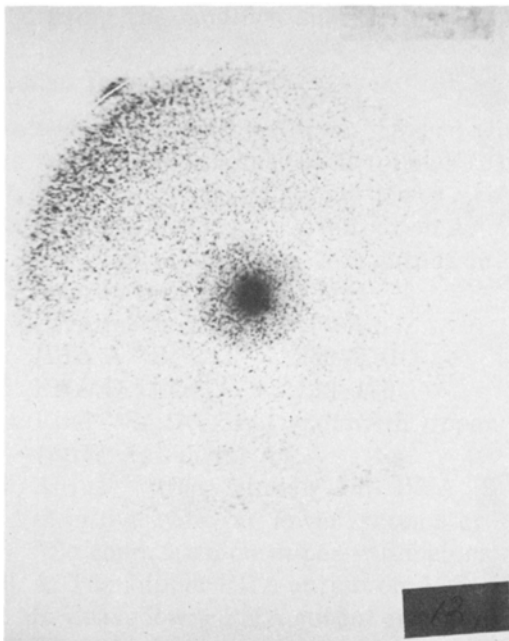
Figure 1 shows a pancreatic scan with an artifact. Immediately after the intravenous injection of  $^{75}\text{Se}$ -selenomethionine, 10-min exposures were obtained at 10-min intervals. While the technologist was developing the first 10-min exposure, a

momentary complete power loss occurred within the department. Later, when the technologist developed the second 10-min exposure, he became quite confused when the scintiphoto showed a bright spot in the center of the image just below the lower hepatic border. The departmental engineer was notified and requested to locate the cause of the bright spot. After an hour of checking and intense testing, he failed to reproduce the bright spot on the CRT of the persistence scope. It was decided to accumulate counts and produce an image during the night to see if the same type of artifact could be reproduced. When the Polaroid of the scintiphoto was developed the following morning, the bright spot had reappeared (Fig. 2).

FIG. 1. Scintiphoto demonstrating line-surge bright spot.

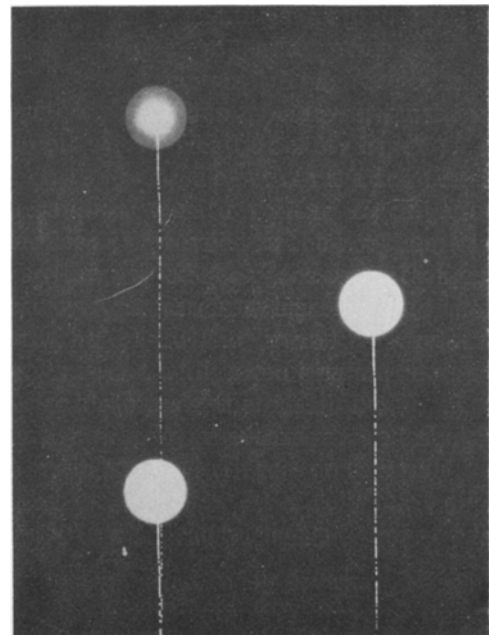
FIG. 2. Bright spot reproduced during overnight image.

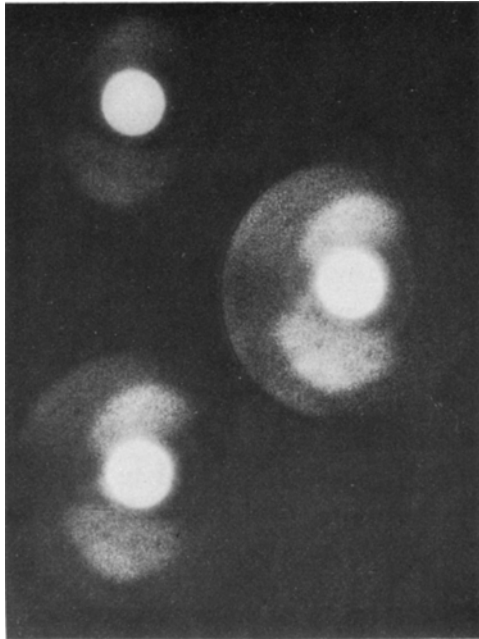
FIG. 3. Scintiphoto showing bright spot appearing during renal scan.

Later the second day while performing a renal scan (Fig. 3) a momentary complete power loss again occurred immediately followed by a line surge. During this procedure, the technologist was facing the console and saw a bright flash in the center of the CRT on the persistence scope. This event and that of the previous day were compared for similarities with the conclusion being that the electrical power fluctuations and subsequently obtained bright-spot photos occurred during electrical storms.
