Radioactive Contamination of Packing Materials from a Xenon-133 Shipment

Michael T. Hackett and Sylvia L. Magoun

Radiation Safety Office and Nuclear Medicine Service, Department of Veterans Affairs Medical Center, Lexington, Kentucky

J Nucl Med Technol 2000; 28:56–59

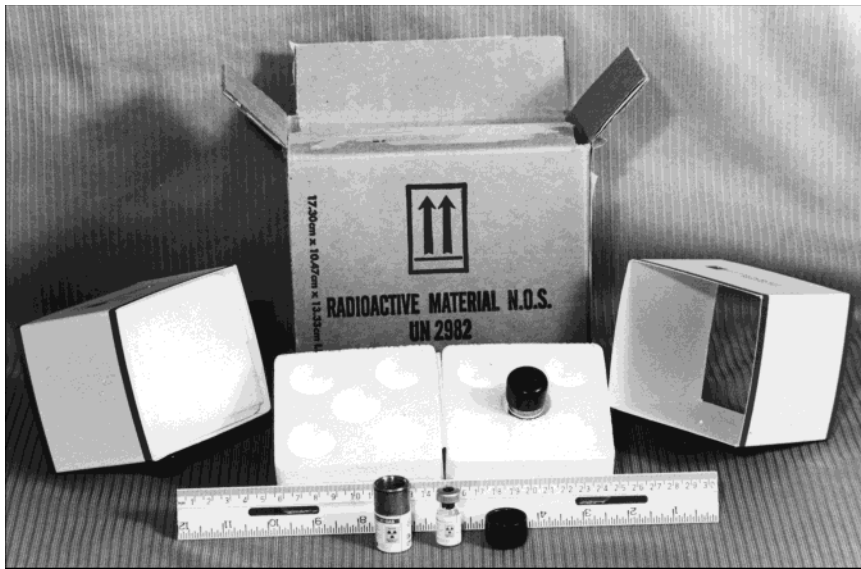
After detecting contamination of the packing materials, the entire package was placed immediately in a fume hood. Individual surveys of the packing materials and the package were repeated to isolate the contamination. Each set of the contaminated polystyrene packing materials (Fig. 1) that held each shielded ^{133}Xe vial were sealed in separate plastic bags. Five-minute computer images were acquired of each set of packing materials using a scintillation camera equipped with a low-energy all-purpose collimator and 20% energy window centered around 81 keV.

FIGURE 1. Packing materials for a shipment of 2 ^{133}Xe vials. Each vial is packed in separate polystyrene packing materials that consist of 2 halves with 5 holes that can house up to 5 shielded ^{133}Xe vials. A single vial is placed in the center hole. Each set of packing materials is placed in a cardboard sleeve to hold the 2 halves together.

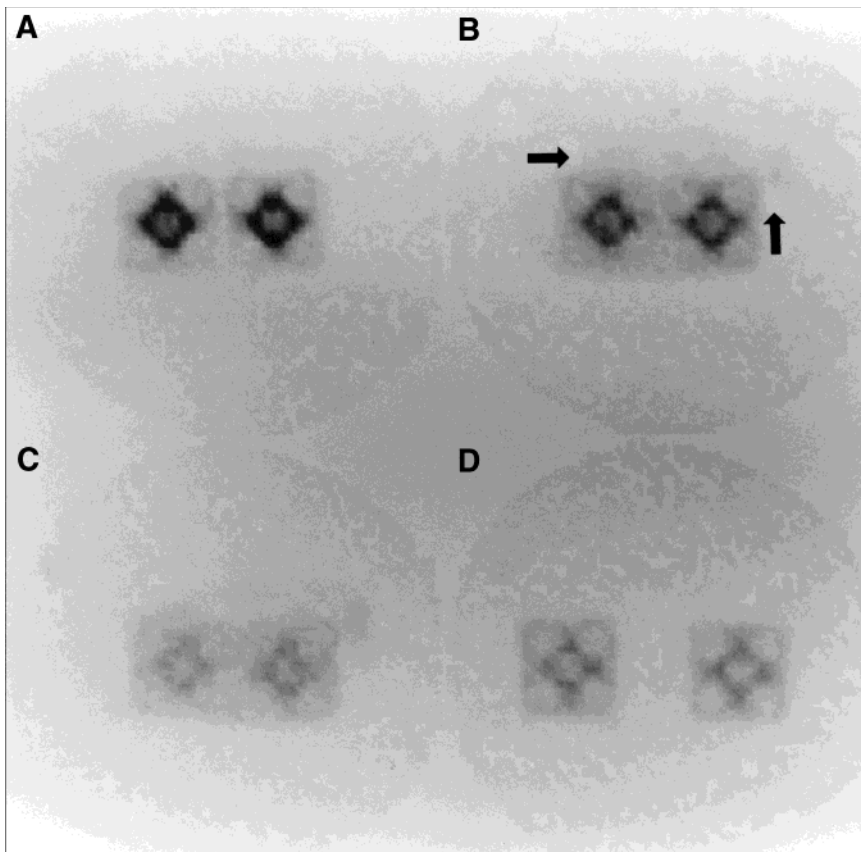
After assaying the second vial, immediate monitoring of the empty package demonstrated contamination of the packing materials with the primary contamination in 1 set of the polystyrene packing materials. Figure 2 demonstrates the contamination was distributed throughout the polystyrene packing materials. The highest concentration was found around the center hole where the shielded ^{133}Xe vial was held during shipping. These images show that over time there was some

Based on the assayed and imaged used ^{133}Xe vial, the ^{133}Xe activity of the contaminated polystyrene packing materials was estimated to be approximately 1628 kBq ($44 \mu\text{Ci}$). This initial image was about 40 min after the package was first opened; therefore, the activity in the packing material most likely would have been higher at the time when it was first opened.

FIGURE 2. Images of polystyrene packing materials that contained the majority of the contamination. The holes of each half used to hold shielded ^{133}Xe vials are facing the camera. (A) Initial image. The 5 holes of each half of the packing materials can be seen with the majority of the counts surrounding the center hole that housed the apparent leaking ^{133}Xe vial. Images B-D are normalized to A. (B) Delay of 0.9 h. Decrease in counts in the center hole with increased counts throughout other parts of the packing materials and into the airspace of the bag (faint activity noted by arrows). (C) Delay of 2.7 h. The overall counts have decreased probably due to leakage of ^{133}Xe from the bag. (D) Immediately after image C was taken, the 2 halves of the polystyrene shipping container were separated and placed in separate resealable bags. D is clearer than C due to the elimination of ^{133}Xe gas from the airspace surrounding the packing material.

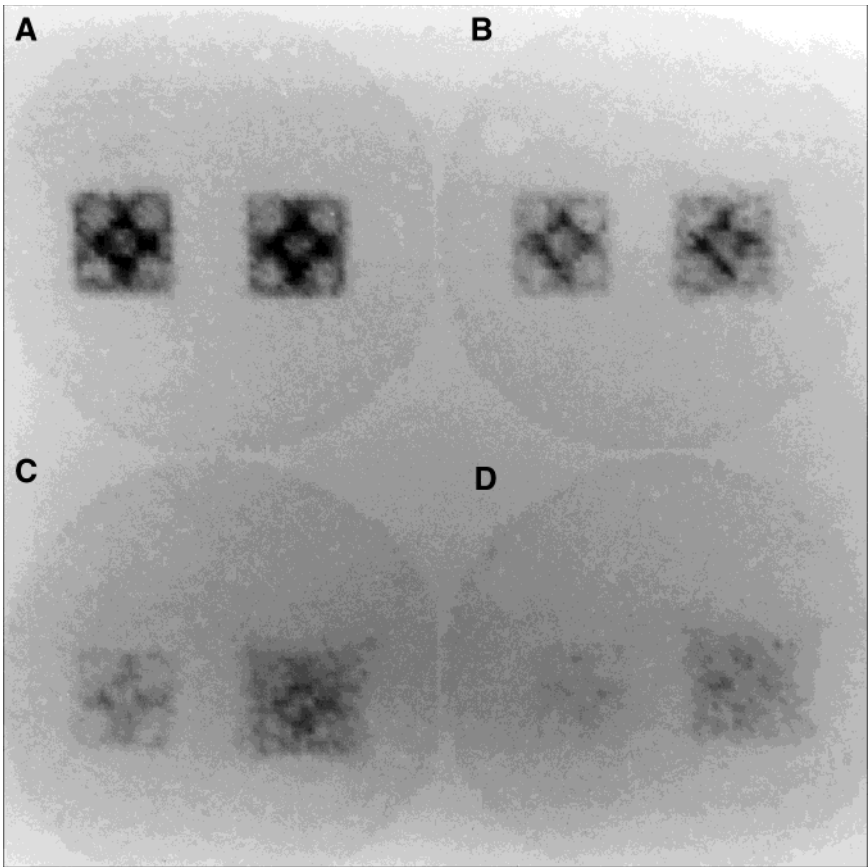
escape of the ^{133}Xe from the polystyrene materials while being enclosed in the plastic bag. Figure 3 demonstrates that ^{133}Xe contamination readily escaped from the polystyrene packing materials that were left unsealed in the fume hood over time.

FIGURE 3. Images of the separated polystyrene packing materials that contained the majority of the contamination. The half on the left of each image was stored out of its bag in a fume hood while the one on the right was stored in its bag. (A) Initial image (same as Figure 2D). Images B-D are normalized to A. (B) Delay of 0.7 h from image 3A. (C) Delay of 2.1 h from image 3A. (D) Delay of 4.2 h from image 3A. Xenon-133 readily left the half that was not stored in a bag although activity was still present after 4 h.

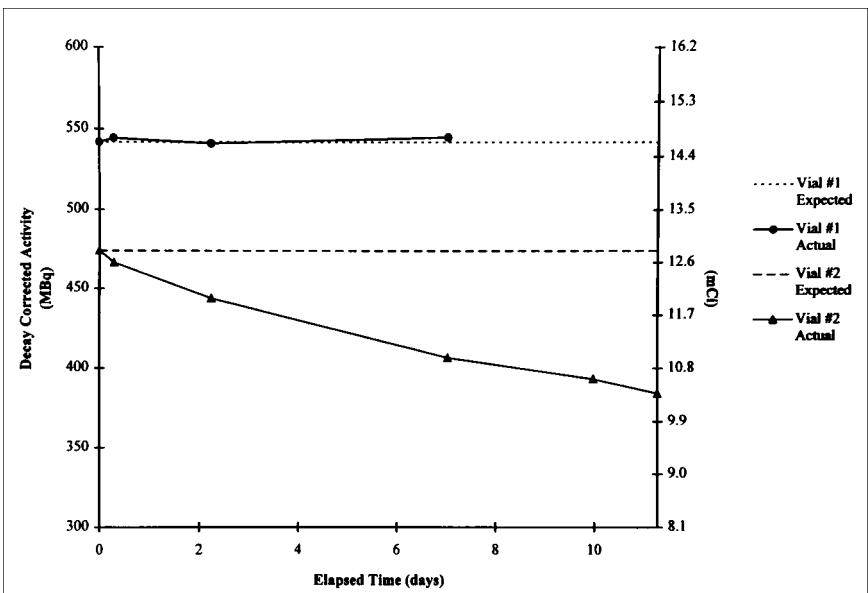
initial assay in the dose calibrator, subsequent assays demonstrated this loss (Fig. 4). The percent difference from the expected activity over time was -1.6% , -6.4% , -14.2% , -17.0% and -18.9% at 0.3 d, 2.2 d, 7.0 d, 10.0 d and 11.3 d, respectively. There was no evident problem (e.g., improper placement of the rubber stopper, damaged metal crimp seal, crack in the glass vial) with the ^{133}Xe vial that could account for

FIGURE 4. Decay-corrected activity of both ^{133}Xe vials over time while being stored in a fume hood until use. The vial that apparently leaked during shipping (i.e., vial 2 with the lower initial activity) continued to leak while the other vial did not.

the leakage. The other ^{133}Xe vial demonstrated no loss of activity over time (percent difference ranged from -0.2 – 0.6% at 0.3 – 7.0 d).

This incident demonstrates that radioactive contamination of packing material from a ^{133}Xe shipment is possible. Monitoring with a survey meter is the definitive step to determine if the packing materials are contaminated before their disposal. Higher external package radiation levels than expected can be a sign that contamination of packing materials may be present. This knowledge will allow the surveyor to take action (e.g., open package in a fume hood) to minimize radiation exposure of themselves and fellow staff members if the packing materials are truly contaminated with ^{133}Xe . The immediate assay of each ^{133}Xe vial will indicate (i.e., lower activity than expected) if any leakage of radioactive gas has occurred. If leakage is detected, the packing materials can be placed in a fume hood, or sealed tightly in plastic bags if a fume hood is unavailable, to minimize exposure. Knowing a ^{133}Xe vial has leaked activity, there is a potential that it is still leaking. The leaking ^{133}Xe vial should be stored in a fume hood until it can be used to minimize radiation exposure of staff members. We recommend that the vial be used for the next ventilation study.
