A Bizarre Ring Artifact on SPECT/CT Images

Sajid Bashir, Muhammad Shahbaz, and Dilber Iqbal

Department of Medical Physics, Punjab Institute of Nuclear Medicine, Faisalabad, Pakistan

J Nucl Med Technol 2017; 45:119–120

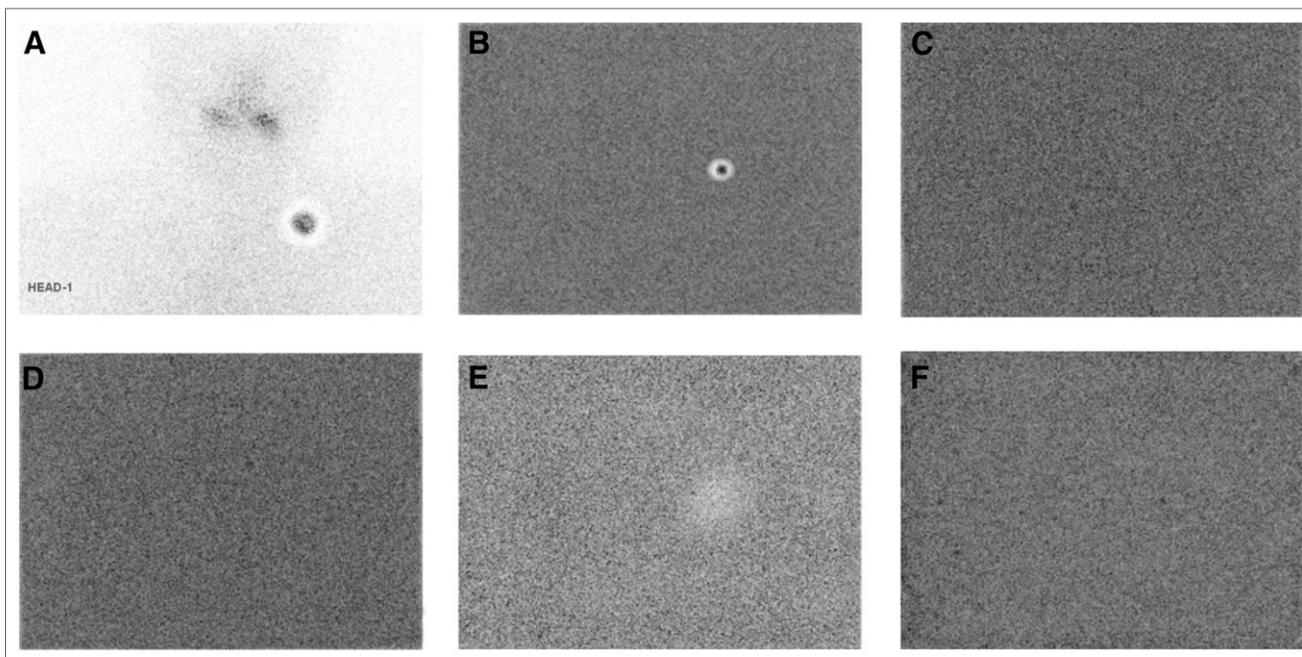
We observed an artifact on images obtained with our Infinia Hawkeye SPECT/CT system (GE Healthcare). The artifact, which was seen on the SPECT portion of the images, consisted of dark and light concentric rings: a broad light ring surrounding a small dark spot. The artifact did not appear on standard clinical images or on images obtained with low-energy radioactive sources. It was first noticed when a patient was scanned using a high-energy source (^{131}I) for whole-body imaging (Fig. 1A), and it was later confirmed in intrinsic flood images obtained with a high-energy 400- μCi (14.8-MBq) ^{131}I point source at a distance of 5 UFOVs (useful fields of view), collecting 4,000 kilocounts (Fig. 1B). Over time, the artifact started appearing with low-energy sources as well. The camera was decommissioned until the

After the artifact started showing up with the high-energy source, we began a thorough investigation. First, peaking (10%) and tuning were done using a $^{99\text{m}}\text{Tc}$ point source to make sure that the window setting and photomultiplier tube voltage gain were within acceptable limits. An intrinsic flood image was acquired by altering the isotope—using a 14.8-MBq $^{99\text{m}}\text{Tc}$ point source placed at 5 UFOVs, collecting 3 million counts. The image was of uniform intensity and showed no artifact (Fig. 1D). However, after a few days, images obtained with the same low-energy source showed a light ring in the same location as on images obtained with the high-energy source (Fig. 1E). When a corrected matrix was applied, the images had one large, ring-type artifact, but images on an uncorrected matrix had a couple of additional spots that were similar to the ring-type artifact but smaller and of lesser magnitude. At that time, the artifact started appearing on images obtained with both low-energy and high-energy sources. We opened the detector head and found that the optical coupling grease between the crystal and the photomultiplier tube had melted and dispersed outward. Fresh optical coupling grease was applied, and subsequent images showed no artifacts (Fig. 1F).

FIGURE 1. (A) Clinical ^{131}I SPECT scan on which artifact was first encountered (high-count dark spot surrounded by broad light ring). (B) Scan with high-energy ^{131}I source confirming existence of artifact. (C) From the morning of the patient scan, daily uniformity scan with low-energy ^{57}Co source showing no artifact. (D) Scan with low-energy $^{99\text{m}}\text{Tc}$ source showing no artifact. (E) A few days later, scan with low-energy $^{99\text{m}}\text{Tc}$ source showing artifact at same position as in high-energy-source scan. (F) After application of optical coupling grease, scan with high-energy ^{131}I source showing no artifact.

for several reasons. Faulty photomultiplier tubes or low or high voltage gain may result in cold or hot rings or an inner and outer halo of lower and higher counts. Maladjustment of the preamplifier and amplifier or a defect in the circuit of the photomultiplier tube can cause ring-type artifacts. In our case, it seemed as if the counts collected by the photomultiplier tube had shrunk to a smaller region, leaving the outer region void of counts. The cause of this problem was found to be leakage of the optical coupling grease. The severity of the artifact correlated with the amount of optical coupling grease dispersed, as evidenced by the corresponding figures. Initially, images taken with a low-energy source were uniform with the exception of a large light spot at the same location as on the ensuing images acquired with high-energy sources. For the images that had shown additional smaller spots on an uncorrected matrix, the optical coupling grease had dispersed to a lesser extent. Dispersion may be due to an increase in the temperature around the photomultiplier tubes. To avoid any thermal stress on the sensitive components of the γ -camera, the temperature gradient should not exceed 5°C per hour.

daily uniformity testing using low-energy sources (a 14.8-MBq $^{99\text{m}}\text{Tc}$ point source or a 370-MBq ^{57}Co flood source). However, it later began appearing consistently in all images regardless of whether a low- or high-energy source was used. The cause of the artifact was found to be gradual leakage of optical coupling grease, possibly because of an increase in local temperature. Fresh optical coupling grease was applied, and the artifact did not appear on later uniformity or patient images.
