Letter to the Editor

A Noisy Photomultiplier Tube: Its Unusual Effect on Gamma Camera Image Uniformity

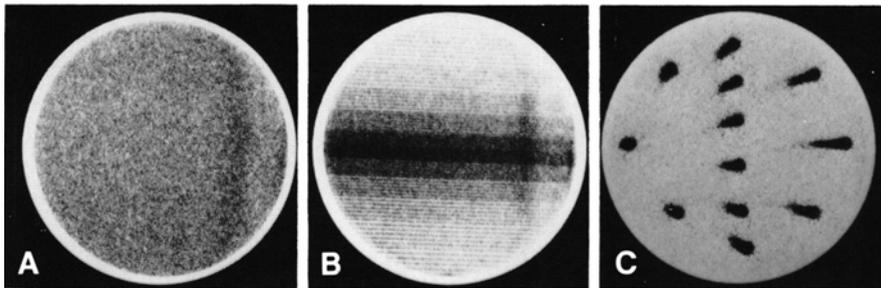
Figure 1A shows an image of an intrinsic flood obtained with a ^{99m}Tc point source. There is a large band of nonuniformity on the right side of the image. An image of a BRH phantom showed a similar nonuniformity with some loss in image resolution (Fig. 1B). The cause of this nonuniformity was initially suspected to be a defective cathode ray tube in the analog image formatter as the degree of nonuniformity varied with repeated flood images. However, a concurrent calibration of the formatter with point sources of ^{57}Co placed on the camera collimator showed a tail on some of the sources. Placement of further sources on the camera yielded the image seen

in figure 1C. Examination of the camera head by the service engineer showed a noisy PM tube. The location of this tube was diametrically opposite the nonuniform area and coincided with the intersection of lines drawn through the tails of the point source images. The reason for the tails on these images was contamination of the pulse arithmetic calculation of gamma ray location. On a random basis, noise from the PM tube was added to the pulse arithmetic signals causing a shift in the positioning of some events toward the noisy PM tube. The errors in pulse positioning increased with distance from the noisy PM tube causing the nonuniformities in the flood image to appear diametrically opposite it.

FIG. 1. (A) Intrinsic flood field image (2 million counts) obtained with a point source of ^{99m}Tc . A dark nonuniform band is present on the right side of the image. (B) Intrinsic image of a BRH phantom obtained with ^{99m}Tc . There is slight loss of resolution on the right side of the image. (C) Extrinsic image obtained using point sources of ^{57}Co placed on the collimator face. Note the presence of tails on the point source images, increasing in length from left to right across the image.

The noisy PM tube was replaced and image uniformity and resolution returned to normal. In our experience this is an uncommon cause of image nonuniformity, but one that can be easily identified by examining images of point sources placed on the gamma camera collimator.
