Foil Collimator Defects: A Comparison with Cast Collimators

Michael J. Blend, Bhupendra A. Patel, Darius Rubas, Carlos Bekerman, and Ernest Byrom

Humana Hospital-Michael Reese, Chicago, Illinois and The Evanston Hospital, Evanston, Illinois

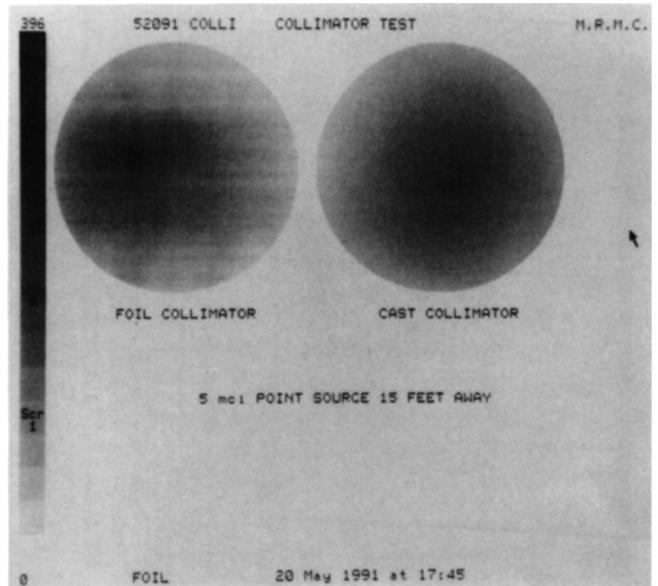
FIG. 2. One-million count planar image of 5 mCi point source of technetium-99m at 5 m (15 ft.) from camera face using a foil collimator and a cast collimator. Note presence of multiple linear defects and large cold spots on foil collimator image and relative lack of linear defects and cold spots on cast collimator image.

Figure 2 shows planar images obtained with the two low-energy, high-resolution collimators and a point source at 5 m from the collimator face. These images represent crude radiographs of the collimators, revealing multiple linear defects in the foil collimator (Fig. 2A) and no defects in the cast collimator (Fig. 2B). The conventional uniformity images obtained with a sheet source at the face of the collimator showed

In this study, we found a consistent problem with a high-resolution low-energy foil collimator that was not seen with a similarly designed cast collimator. A simple but “old” test dramatically illustrated this problem. When a point source was placed 5 m from the face of the foil collimator, the image demonstrated a pattern of lines of varying intensity. In 1983, Yeh (6) published a description of a similar type of defect in a hexagonal (foil type) collimator, which was reportedly due to small design defects in the foils as they came together to form the hexagonal channels.

Evaluation of collimators during acceptance testing should include images of activity positioned away from the face of the collimator, e.g., SPECT phantom images or a distant

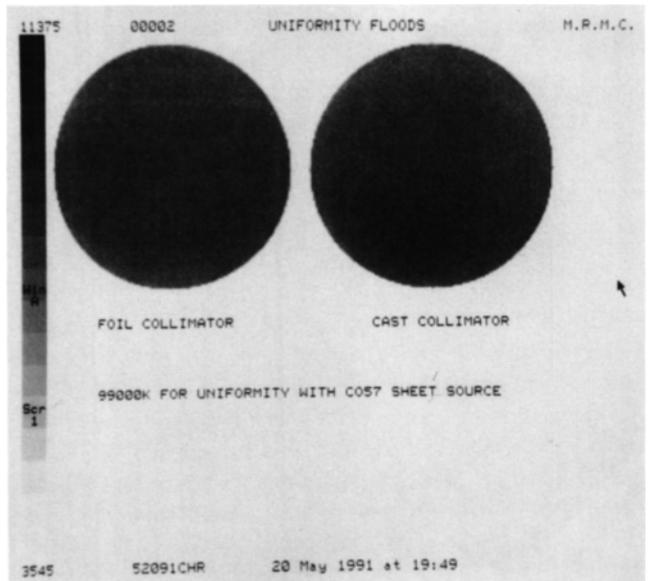
FIG. 3. Two one-million count planar images using sheet source at face of camera. Image at right is formed with use of cast collimator; no defects are noted. Image at left is formed with use of foil collimator and some questionable linear defects can be seen.

no defects with the cast collimator and only minor or questionable defects with the foil collimator (Fig. 3).

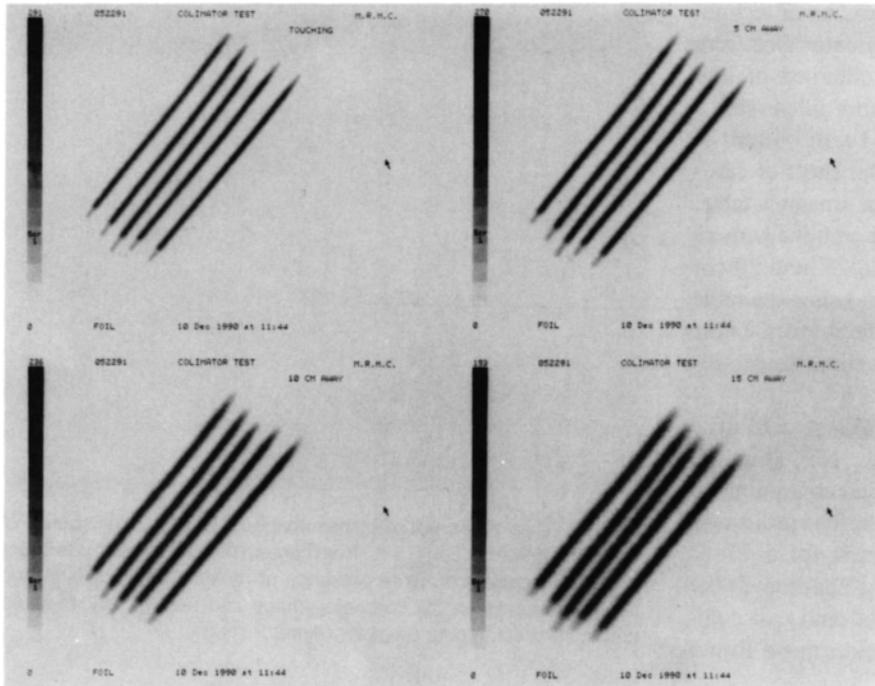
The line sources were set diagonally in the field of view to avoid alignment with the defects. Visual inspection reveals horizontal streak artifacts crossing the diagonal line images at 15, 20, 25, and 30 cm from the camera face with the foil collimator (Fig. 4). No artifacts are seen in the cast collimator images (Fig. 5).

FIG. 4. Multiple planar images of line sources at 0, 5, 10, and 15 cm from face of camera using a foil collimator. Note linear defects in images obtained at 10 and 15 cm from camera face.

Collimators sometimes suffer from defects of construction. These defects may be invisible in a sheet-source image made with the source at the face of the collimator. However, the defects are clearly apparent in a radiograph, or in the image of a distant point source. The resultant artifacts in planar images are more apparent for sources at greater distances

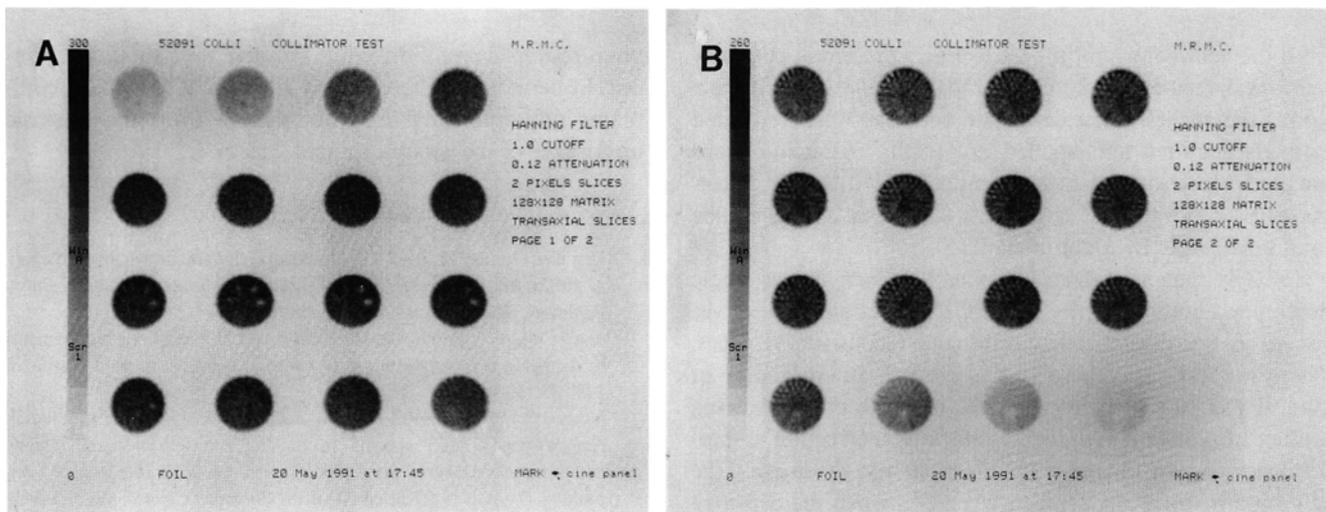
FIG. 6. Multiple reconstructed transaxial slices of SPECT images of phantom, acquired using foil collimator: (A) slices 1–16; (B) slices 17–32. Note ring artifacts in slices 1–3, 22–23, and 26–32.

slices through a SPECT phantom filled with a solution containing 10 mCi of ^{99m}Tc . Note the ring artifacts in slices 1–3, 22–23, and 26–32 in the transaxial sections of the phantom, when using the foil collimator. These artifacts were observed on five separate occasions with two different GE SPECT gamma camera systems. The defects are more apparent on the images reconstructed after prefiltering (Fig. 6). There are no ring artifacts when the cast collimator is used (Fig. 7).

SPECT imaging, especially, involves activity at these depths, and nonuniformity of SPECT projection images gives rise to ring artifacts in the transaxial reconstructed slices. These artifacts could cause serious errors in interpretation of clinical images (7). In our SPECT reconstruction, the ring artifact appears even though uniformity correction is performed using an image of the sheet source made with the same collimator. Ring artifacts were seen when the defective foil collimator was used, but not with the cast collimator.
