# Collimator-Induced Defects in Planar and SPECT Gamma Camera Images: A Multicenter Study

Michael J. Blend, Bhupendra A. Patel and Ernest Byrom

Section of Nuclear Medicine, University of Illinois Hospital at Chicago; Division of Nuclear Medicine, Michael Reese Hospital, Chicago; and Division of Cardiology, The Evanston Hospital, Evanston, Illinois

*J Nucl Med Technol* 1995; 23:167-172

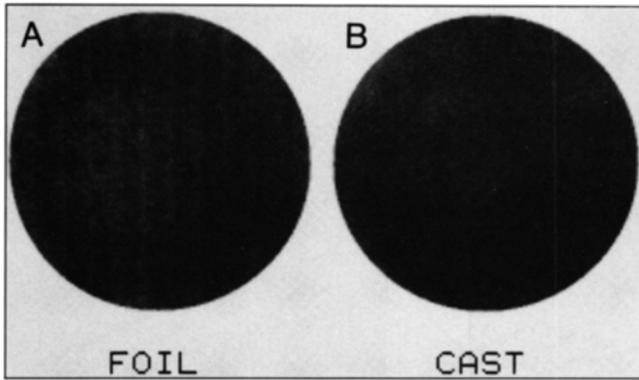
**FIGURE 1.** Two high-count images (99 k) of a  $^{57}\text{Co}$  uniformity sheet source placed at the collimator surface. Image (A) was obtained with an HRFC and image (B) an HFCC. Significant differences between the two images were not visually appreciated. This was a consistent finding among the 10 institutions.

Figure 1 demonstrates two high-count images (99 million) of a single  $^{57}\text{Co}$  sheet source; image (A) was obtained with an HRFC in place and image (B) was obtained with an HRCC. Visual inspection failed to reveal any significant differences in uniformity between the two images. This was a consistent pattern noted at all the institutions using either a cast or foil collimator and a high-count  $^{57}\text{Co}$  sheet source.

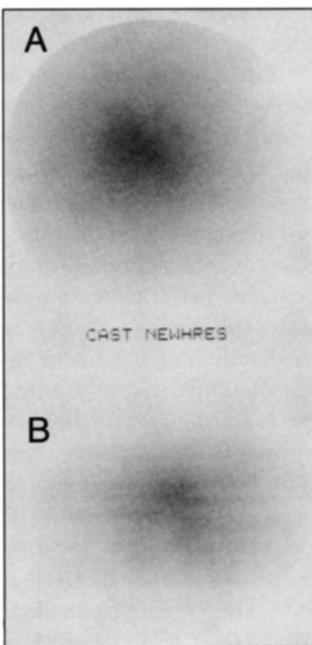
Figure 2 shows a planar image of a distant point source obtained with an HRCC (A), and a similar image obtained with an HRFC (B). This example is one of the worst case displays we noted when a single-point source was placed 5 m from the collimator face in the center of the field. These

**FIGURE 2.** Two planar images of a distant point source at 5 m from the collimator face in the center of the field. Image (A) was obtained with an HRCC, and image (B) with an HRFC. Note linear defects in the foil collimator image.

images represent crude radiographs of the collimators, revealing multiple linear defects in the HRFC image but not in the HRCC image. In 9 of 10 institutions, hot and cold linear artifacts were seen with the HRFC and not with the HRCC. All institutions that used the standard HRFCs demonstrated linear artifacts. At the one institution where the two HRFCs tested were from the same manufacturer, linear artifacts were noted on the standard HRFC but not in the new foil collimator made by a semiautomated process. Figure 3 presents two planar images of a distant point source at 5 m from the collimator face. Figure 3A was obtained with an HRFC constructed by a new semiautomated manufacturing process. Figure 3B was obtained with an HRFC constructed by the standard method. The point source images obtained with the HRFC constructed by the new semi-automated process demonstrated a similar uniformity pattern as those obtained with HRCCs.

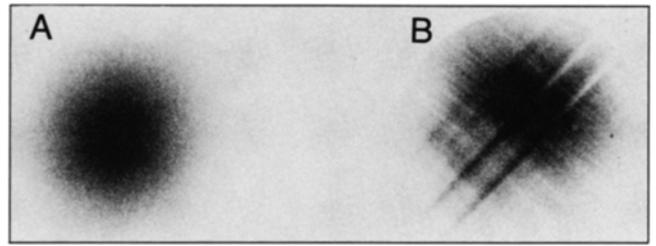
**FIGURE 3.** Two planar images of a distant point source at 5 m from the collimator face. Image (A) was obtained with an HRFC constructed by a new semi-automated manufacturing process. Image (B) was obtained with an HRFC constructed by the standard method. Note the vast differences in uniformity between images A and B.

There are basically two types of collimator design used for gamma cameras today. The first type is the foil collimator which usually is constructed by affixing lead foil strips with glue, producing hexagonal holes. If the construction is less than perfect, photons can pass between the strips allowing for in-foil alignment errors. Additional artifacts can be induced in the final image if the connections between the strips come apart during the manufacturing process, shipping or routine changing of collimators on the camera. Several companies have recently changed the manufacturing process to heat sealing or melting the foil strips in place instead of relying exclusively on glue. One manufacturer has converted to a semi-automated robotic handling of lead strips, which includes corrugation preforming, high-pressure die-forming,

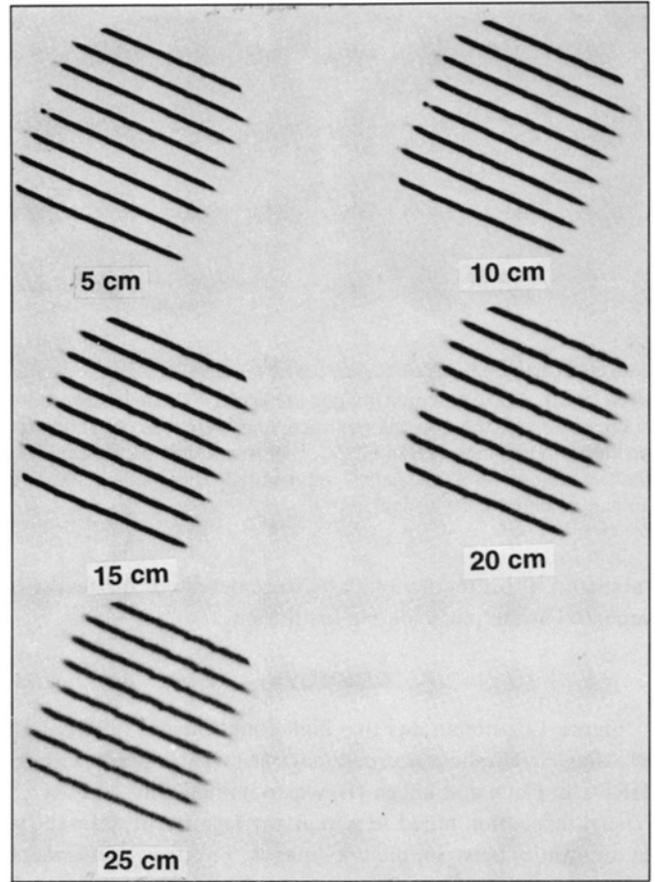
Multiple line sources were set diagonally in the field of view of the gamma cameras in order to avoid source alignment with the previously noted linear artifacts in the point source images. HRFC images demonstrated horizontal cold linear artifacts crossing the diagonal lines in images at 15, 20, 25 and 30 cm from the face of the camera. Similar artifacts were not seen in the HRCC images at these distances. These artifacts were consistently seen in all institutions using the HRFCs and are similar to the artifacts illustrated in our previous work (1). Figures 4 and 5 show planar images of multiple line sources placed at 0, 5, 10, 15, 20 and 25 cm from the collimator face using the new semi-automated HRFC (Fig. 4) and the standard HRFC (Fig. 5). Again, the new HRFC model did not demonstrate cold linear defects in the line source images.

**FIGURE 5.** Planar images of multiple line sources placed at 5, 10, 15, 20 and 25 cm from the collimator face using the standard HRFC. Multiple linear artifacts are noted.

The line source images indicate the depth at which the defects begin to have an effect. At 0 to 15 cm from the collimator face defects are not visible, but at greater distances the line sources show cold artifacts when HRFCs are used. While these artifacts have not been identified in clinical planar images, where they may be obscured by multiple extended sources and background, they present problems for SPECT reconstruction which necessarily includes structures at distances greater than 15 cm.

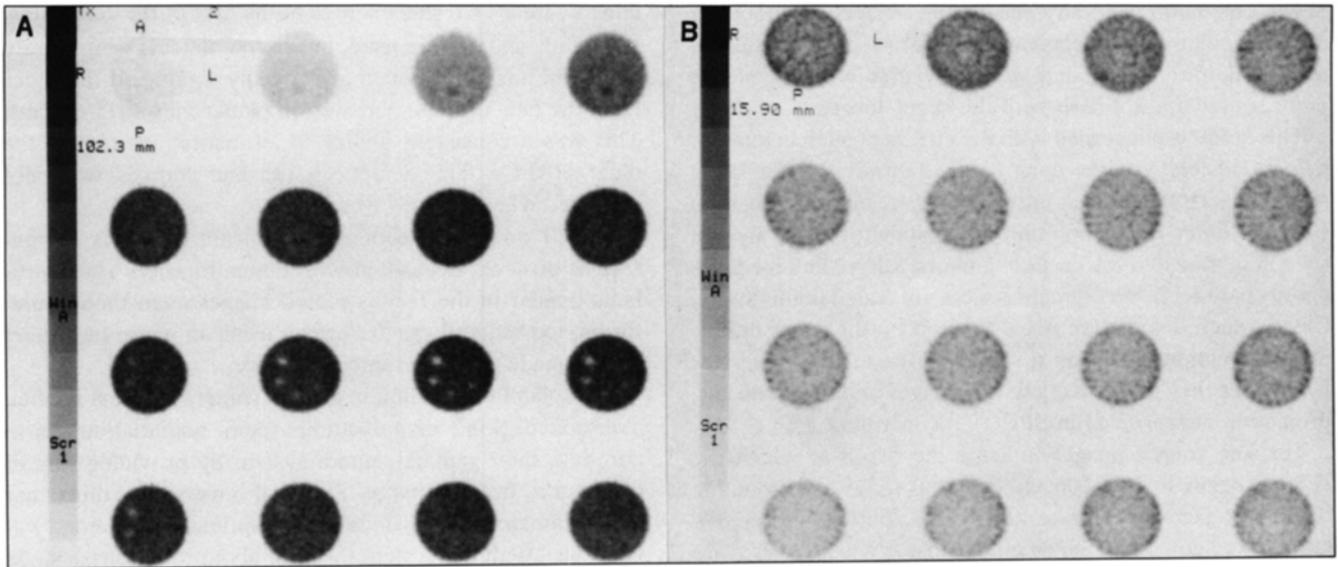
Reconstructed SPECT phantom images of data collected with HRFC and HRCC showed consistent differences. Figures 6 and 7 demonstrate multiple 2-pixel thick transaxial slices through the Data General SPECT Phantom from one institution. Multiple artifacts in slices 1 to 5 (Fig. 6A), and 22 to 30 (Fig. 6B) were noted. No ring artifacts were observed when an HRCC was used (Fig. 7A, B). These ring artifacts are seen only with the HRFCs and are more apparent on the images reconstructed after prefiltering. These defects are not seen when the HRCC or recent model machine-made HRFC were used. As with the planar artifacts, there is consistent visualization of ring artifacts in a comparable number of

**FIGURE 6.** Multiple reconstructed transaxial images of a SPECT phantom acquired with an HRFC. Ring artifacts in slices 1 to 5 (A) and 22 to 30 (B) were seen. Similar ring artifacts were noted at the end slices of the phantom images in all five institutions when data were acquired with the standard HRFC.

These artifacts are comparable to uncorrected nonuniformities in that they appear at the same place in the field of view in each of the 60 or 64 projection images. In transaxial reconstruction, the backprojection operation combines them into an annulus, centered on the axis of rotation. These ring artifacts (4) are much more prominent in transaxial sections than the original nonuniformities in the planar image. Thus, uncorrected collimator defects are of greatest concern for SPECT imaging.

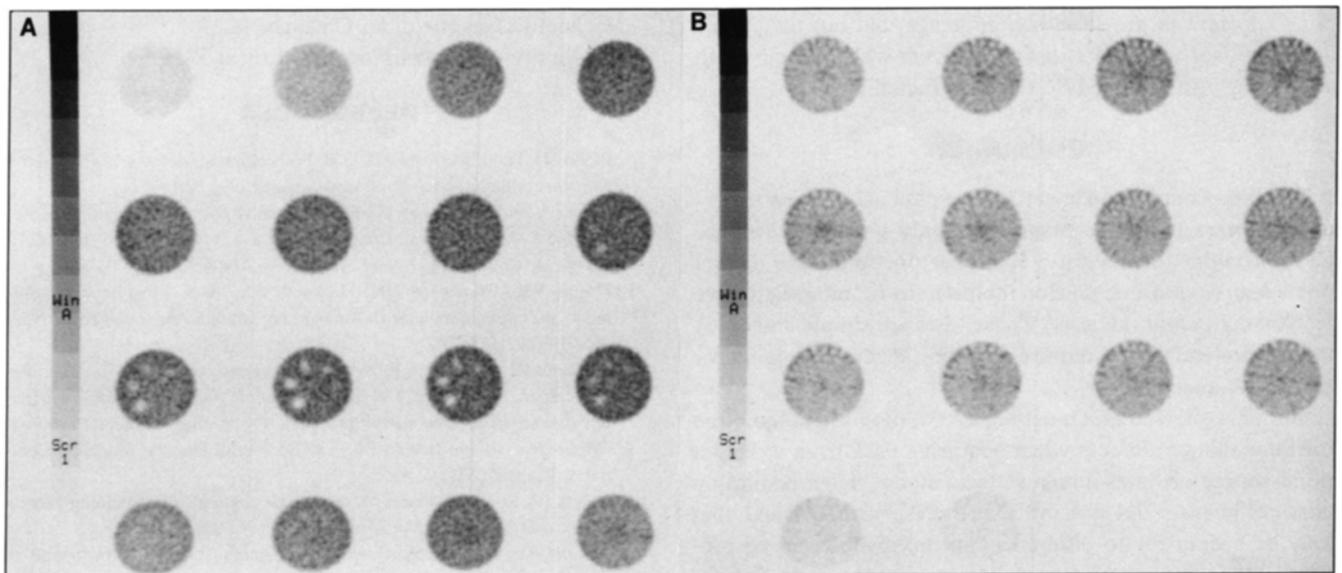
**FIGURE 7.** (A) Multiple reconstructed transaxial images of a SPECT phantom acquired with an HRCC are presented. (B) No ring artifacts were noted in any of the five institutions' images when a cast collimator was used.
