# Photomultiplier Tube Artifacts on $^{67}\text{Ga}$ -Citrate Imaging Caused by Loss of Correction Floods Due to an Off-Peak Status of One Head of a Dual-Head $\gamma$ -Camera

**J Nucl Med Technol 2012; 40:278–280**

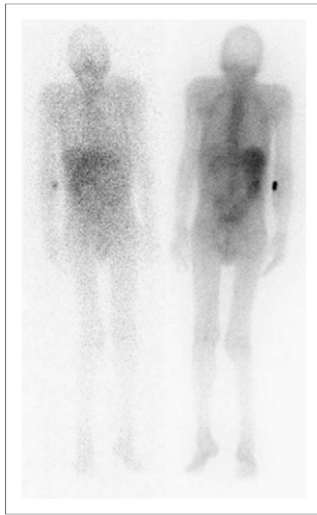
Anterior and posterior whole-body and static images demonstrated normally distributed radiotracer activity with no suggestion of infection. However, the patient's images also revealed another interesting, unrelated finding. The whole-body study showed an appreciable difference in image quality between the anterior and posterior images. An apparent reduced number of counts and poor image quality could be seen in the anterior whole-body image (Fig. 1).

**FIGURE 1.** Anterior and posterior whole-body images obtained with detectors 1 and 2, respectively, showing marked decrease in counts and image quality on anterior projection. No distinct PMT outlines are detectable.

The individual photomultiplier tubes were not seen on the whole-body images because of the moving detector heads; the outlines were blurred and the photomultiplier tube defects were filled in as the counts were being acquired, stored, and processed. Closer scrutiny revealed a subtle photomultiplier tube pattern over the patient's head in the anterior view (Fig. 1) because detector 1 was stationary for several seconds at the commencement of image acquisition before moving continuously over the whole body.

It was later discovered that the correction floods for detector 1 had been corrupted, causing the off-peak appearance even though the proper  $^{67}\text{Ga}$  window had been configured and the medium-energy collimator was in place. This problem was resolved the same day after on-site vendor service had been provided and appropriate corrections had been made. No faulty photomultiplier tubes were found at the time of servicing. It was also verified that the appropriate correction flood for  $^{67}\text{Ga}$  had been used before the study began.
