# An Unusual Cause of the Ring Artifact on Transaxial CT Images

Artifacts and image quality are two sides of the same coin. The ring artifact is scanner-based and caused mainly by either a miscalibrated element or a defective element of a detector row. We describe a rare cause of the ring artifact that appeared on a transaxial CT image because of a loose electronic contact. To our knowledge, this particular cause of the ring artifact has not been described in literature.

**J Nucl Med Technol 2016; 44:214–215**

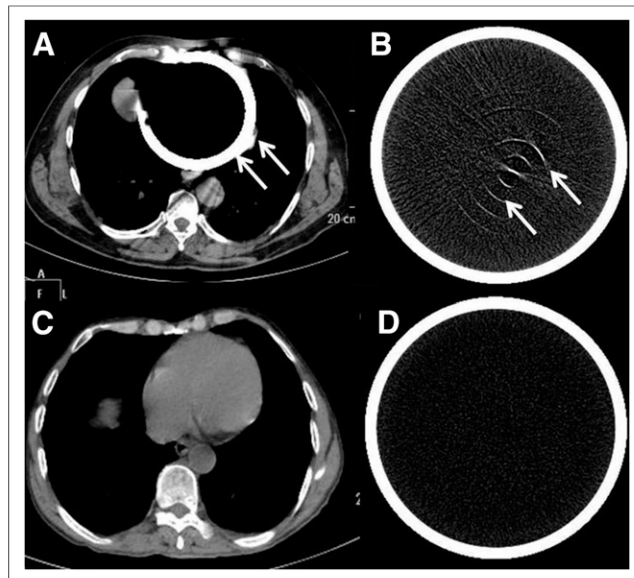
We encountered the ring artifact on a transaxial CT image while performing routine PET/CT on a 64-slice time-of-flight Gemini TF 64 scanner (Philips) (Fig. 1A, arrows). The artifact persisted on the CT scan of the uniformity phantom (Fig. 1B, arrows) and remained even after cleaning of the Mylar (DuPont Teijin Films) window with warm water. The service engineer performed the bad-detector test to rule out the possibility that the artifact was caused by

defective detector modules. Modules 21 and 26 did not pass the test. Two possibilities for the defect were suspected, either an electronic issue within the detector module or a loose connection between the module and the motherboard. Because the first cause would have required replacing the detector module, we tried to rule out the second cause—a loose connection. Both modules were reset in the motherboard, and the bad-detector test was repeated. This time the test did not reveal a problem with any of the modules, including 21 and 26. We then performed CT scanning of the uniformity phantom and found that the ring artifact had disappeared (Fig. 1D). We repeated the scan to confirm disappearance of the artifact. Before starting clinical imaging, we performed an air calibration test. We resumed clinical imaging after obtaining a satisfactory result from this test, and the ring artifact was not present on the clinical images (Fig. 1C).

**FIGURE 1.** Ring artifact (arrows) present on transaxial CT image of thorax (A) and uniformity phantom (B). Disappearance of ring artifact from both thorax image (C) and phantom image (D).

The ring artifact on transaxial CT images may be due to an unusual cause such as a loose electronic contact, which does not require expensive replacement of the detector module or significant downtime. This cause of the artifact can be avoided by maintaining the strict environmental conditions prescribed by the manufacturer.
