# The Need for Increased Awareness About Potential Quality Control Problems in Aging $\gamma$ -Cameras

Sarah Frye<sup>1</sup>, Ross Frye<sup>2</sup>, Barbara Sterkel<sup>2</sup>, Razi Muzaffar<sup>3</sup>, and Medhat M. Osman<sup>3</sup>

**J Nucl Med Technol 2019; 47:223–226**

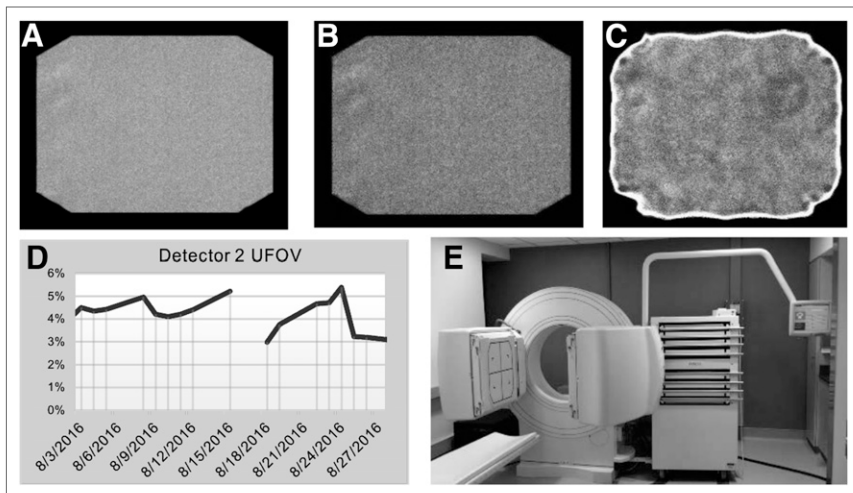
**FIGURE 1.** (A) Extrinsic QC uniformity image from detector 2 on August 15, 2016 (15 million counts, gray scale). (B) Extrinsic QC uniformity image from detector 2 on August 15, 2016 (15 million counts, thermal intensity increased to 91% [printed in gray scale]). (C) Intrinsic QC uniformity image from detector 2 on August 17, 2016, with mask removed (11.706 million counts, thermal intensity at 12% [printed in gray scale]). (D) Line graph of daily integral uniformity measurements of useful field of view (UFOV). (E) Image of Forte  $\gamma$ -camera at VA Saint Louis Healthcare System, John Cochran Division, St. Louis, MO (5).

field-of-view value that was slowly increasing (Fig. 1D) (5). Most of the rising values were not significant enough to raise alarm during QC, as the results were within the manufacturer recommendation of less than a 5% deviation. The manufacturer recommends that both intrinsic and extrinsic uniformity floods be 15 million counts at 20,000–50,000 counts per second for Epic detectors on the Forte (Mark Schmidt, written communication, January 4, 2019). This recommendation was followed by the department, and the figures in

this article include the total counts for each image. Once the 5% deviation range was reached, the scanner was taken out of service. Because the daily uniformity values had been increasing over the previous several days, the technologists kept watch on the QC and patient images to ensure no problems were present. The Forte (Fig. 1E) had undergone routine maintenance since its installation in 2003. On in-depth QC image review, there was a photopenic circular image artifact noticed on the day the scanner was taken out of service (Figs. 1A and 1B), which resulted in a call to the field service engineers.

The field service engineers performed intrinsic QC uniformity with the mask removed (Fig. 1C) and found that detector 2 would require a rebuild. A rebuild involves disassembly of the detector, cleaning of all coupling gel from each PMT and from the crystal/light-pipe assembly, and then application of new coupling gel to the tubes followed by their reinstallation. A rebuild is necessary when the gel gets old or too hot and air bubbles form between the tube and light pipe or when the tubes fail (Mark Schmidt, written communication, February 22, 2018) (5). As part of the rebuild, the service engineers tuned the PMTs. Because of the cathode excitation, the service engineers predicted that a second or third tuning might be necessary. Cathode excitation can occur when the tube is exposed to light, and the tube may need to remain in darkness for several hours or days (Fig. 2D). Historically, tuning was the original uniformity correction technique applied to  $\gamma$ -cameras and involved adjusting the high voltage to individual PMTs to produce equal count rates across the field of view (6). Manual tuning is performed infrequently in modern  $\gamma$ -cameras because of the large number of PMTs (6).

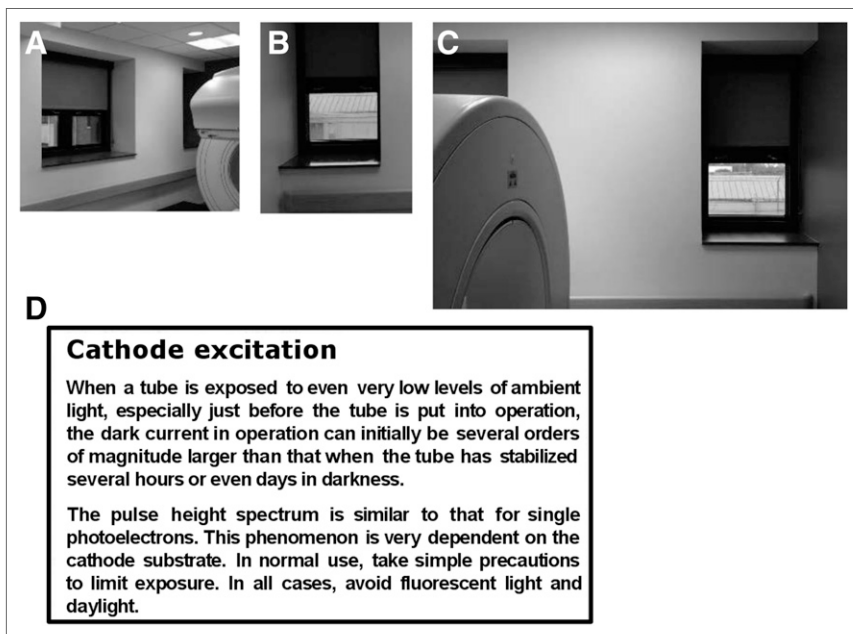
**FIGURE 2.** (A) Photograph of windows and ceiling with fluorescent light in Forte  $\gamma$ -camera room. (B) Photograph of second window. (C) Photograph of third window (5). (D) Excerpt from Photonis PMT manual (7).

2D) noted that light should be avoided when one is working with the cathode substrate (photocoupling gel) (7). Avoiding light in an imaging room can be difficult if the room has windows (Figs. 2A–2C). The excitation issue may have caused the loss of tuning after the initial detector rebuild, which caused the second artifact and the required retuning. Because this was an older  $\gamma$ -camera, a tuning session of 4 h was required to adjust the voltage signal on the PMTs. Older equipment has older hardware. Hardware degrades over time, and some of the electronic parts in this  $\gamma$ -camera had been replaced. It was difficult for us to determine the exact cause of the slowdown of this  $\gamma$ -camera, which had been in use for approximately 13 y.

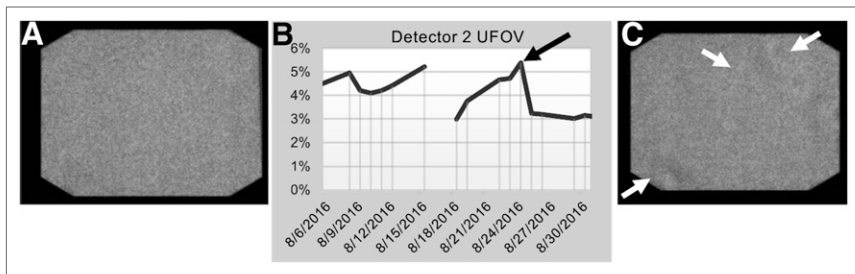
**FIGURE 3.** (A) Extrinsic QC uniformity image from detector 2 on August 18, 2016 (15 million counts, thermal intensity at 91% [printed in gray scale]), after detector rebuild. (B) Line graph showing QC problems again; arrow points to August 24, 2016, which was after first rebuild. (C) Extrinsic QC uniformity image from detector 2 on August 24, 2016 (15 million counts, thermal intensity at 91% [printed in gray scale]). Extensive modeling (arrows) across field of view is due to PMT excitation; tuning was done to remove modeling (5). UFOV = useful field of view.

coupling gel. Detector 2 was functional again 2 d later (5). The extrinsic QC imaging (Fig. 3A) was satisfactory again, but a new artifact was introduced 4 d later (Fig. 3C). The cause of this artifact was cathode excitation, which required a tuning session (5). Because the new artifact looked like the first artifact, a person with an untrained eye might have performed another time-consuming rebuild with new gel, when only tuning of the detector was required. The uniformity values were increasing again (Fig. 3B), and the scanner was operating outside the acceptable range. Servicing was once again requested to assess the problem, resulting in another 1.5 d of service work (5). After this additional work of tuning the PMTs, the service engineers stated that another tuning might be necessary in several days if the extrinsic QC increased. The tubes were given time to stabilize, and the gel was given time to set; after 4 wk, it was determined that a third tuning was unnecessary (Figs. 4C and 4B). After the second tuning, an extrinsic flood test showed uniform images (Fig. 4A). When the extrinsic QC passed the test, an intrinsic flood image was acquired to prove that a third tuning was unnecessary (Fig. 4C) (no extrinsic image was included

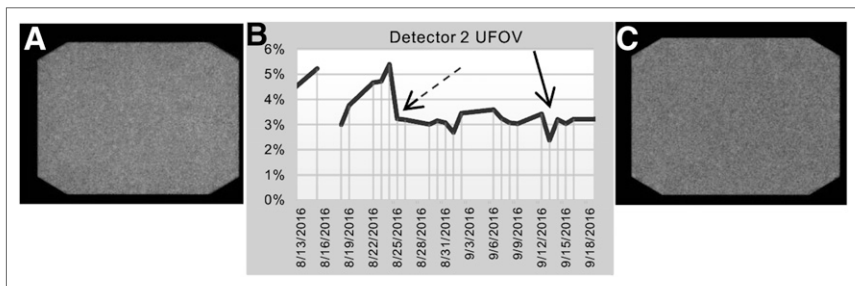
**FIGURE 4.** (A) Extrinsic QC uniformity image from detector 2 on August 25, 2016 (15 million counts, thermal intensity at 91% [printed in gray scale]), after second tuning. (B) Line graph showing extrinsic useful field of view on August 25, 2016 (dashed arrow), and extrinsic QC uniformity on September 14, 2016 (solid arrow), which is when detector 2 might have needed another tuning. Another tuning was not needed per the QC results. (C) Intrinsic QC uniformity image from detector 2 on September 14, 2016 (15 million counts, thermal intensity at 91%). Extrinsic QC image was not captured on that day (5). UFOV = useful field of view.
