Root Cause Analysis of Na¹³¹I Contamination

Key Words: root cause analysis; Na¹³¹I contamination; radioiodine therapy; hyperthyroidism

J Nucl Med Technol 2021; 49:350–353
DOI: 10.2967/jnmt.121.262492

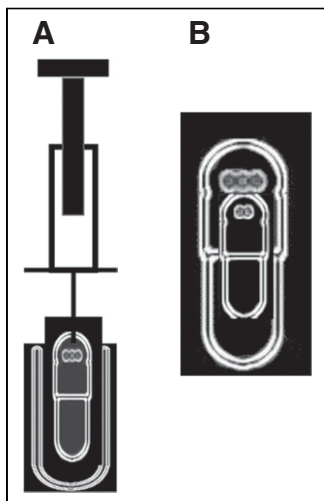
The AU called the radiopharmacy to obtain Na¹³¹I in liquid form, but it would not be available for another 3 d because the request was being made on a weekend. Since the patient was not willing to return after 3 d, the AU decided to open the Na¹³¹I capsule in the dosing room and empty the contents into a cup of water for the patient to drink. The AU and resident first tried to open the capsule with gloved hands over a cup of water placed on a counter in the treatment room. The Na¹³¹I capsules supplied by the vendor have Na¹³¹I solution injected directly into a small capsule, which is enclosed within a larger capsule. Figure 2 demonstrates the preparation and configuration of these Na¹³¹I capsules.

FIGURE 2. (A) Injecting Na¹³¹I into center of inner small capsule. (B) Slipping upper half of large capsule over bottom half to completely cover small capsule, which is then gently pushed down until locked.
