Misleading Results with a Bar Phantom Image

W.J. Maguire

Methodist Hospital, Memphis, Tennessee

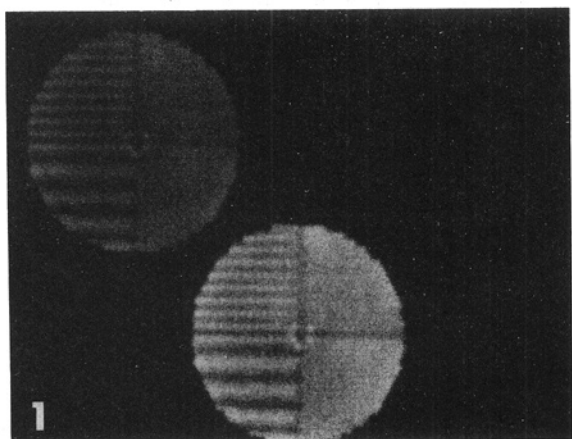
The image obtained caused further confusion (Fig. 1). Little could be distinguished in the two quadrants on the right; the left quadrants exhibited light and dark bands of different sizes, which one would expect with a bar phantom image. Most surprising, however, was that the light and dark bands in these two quadrants were parallel, whereas the bars in adjacent quadrants of the bar phantom were perpendicular.

Figure 9 shows another pattern that can occur when the bars are parallel to a row of holes. This interaction causes the appearance of light and dark bands, which are perpendicular to the bars. This effect, combined with the effect shown in Fig. 8, is responsible for the appearance of parallel lines in the two quadrants of Fig. 1.

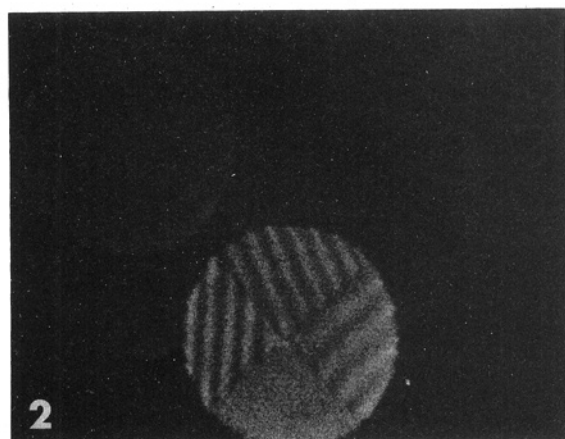
The phantom was rotated 45° counterclockwise and another image was obtained (Fig. 2). In this image the lines seen in adjacent quadrants were neither parallel nor perpendicular. Figures 3, 4, and 5 were obtained by rotating the phantom an additional 45°, 45°, and 15° counterclockwise, respectively. These pictures were equally puzzling. Some of the anomalies noted were that in Fig. 3 the lines in adjacent quadrants were again parallel as in Fig. 1, but in Fig. 4 they were not parallel; some of the lines in Fig. 3 appeared broken and interdigitated, rather than continuous; and in some but not all cases, a 45° rotation of the phantom caused a 90° or more change in the direction of the lines.

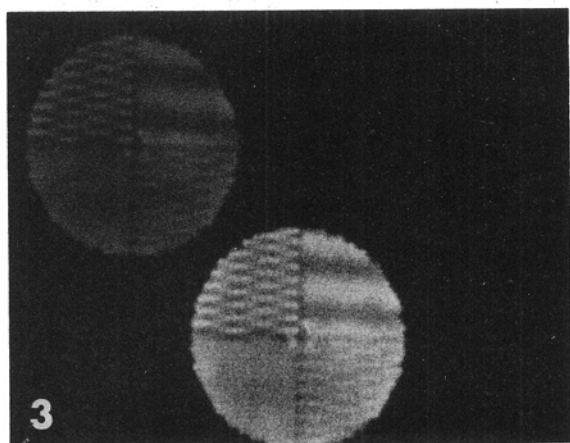
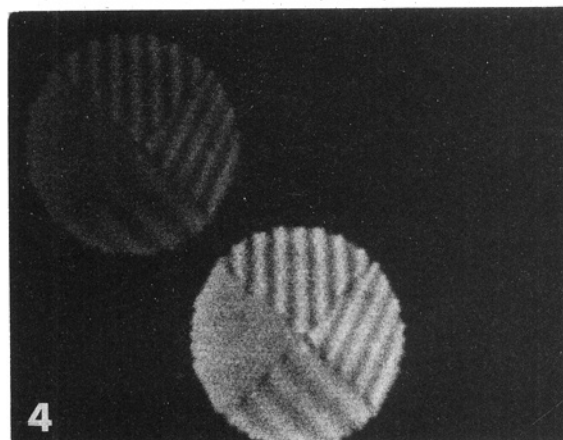
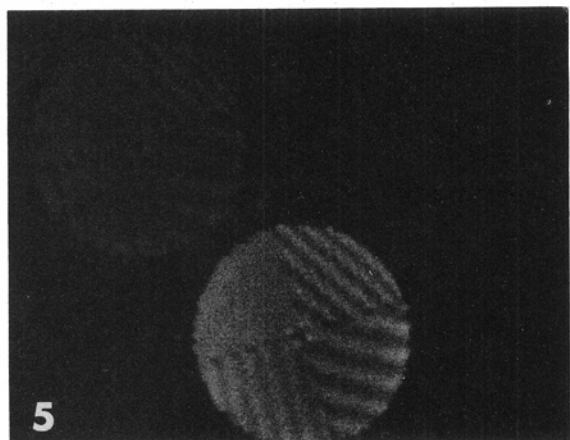
apparent 90° rotation of some of the lines between figures 4 and 5 when the phantom had been rotated only 15°.

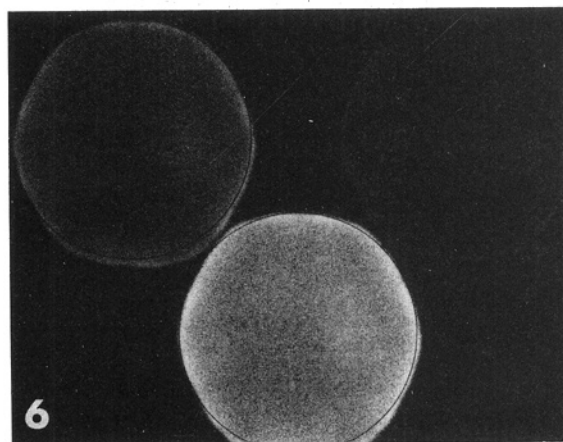
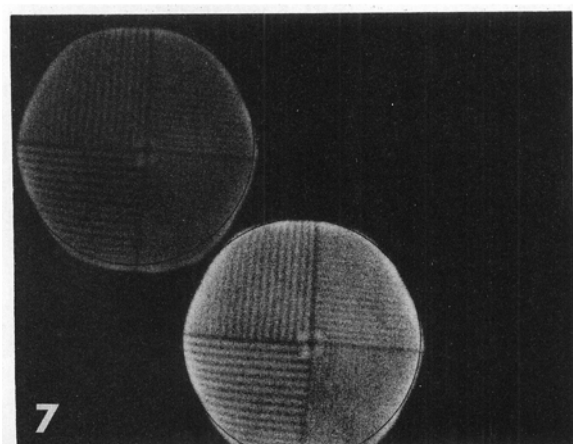
The collimator was removed so that a flood field could be performed (Fig. 6) and an image was made of the phantom placed directly on top of the crystal (Fig. 7); both were normal.

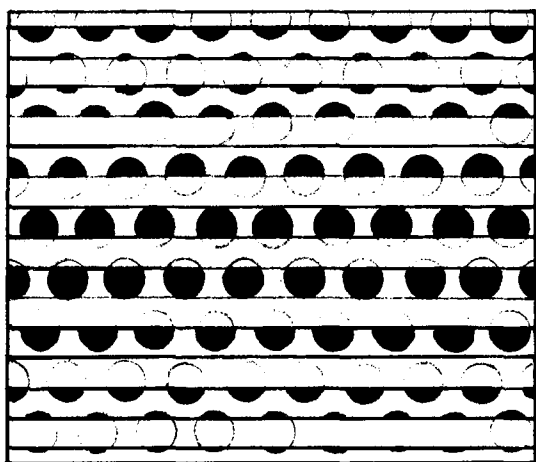
Figure 8 shows one type of interference pattern in which the bars form a repeating pattern of being in and out of phase with the rows of holes. The light and dark zones seen in the images are areas in which the holes are alternately covered and uncovered by the bars. The light and dark zones caused by this pattern are parallel to the bars, and different bar sizes cause patterns of different sizes. This type pattern can be seen in at least one quadrant of each of figures 1–5.

FIG. 8. Bars interact with rows of holes to form wide light and dark bands parallel to bars. Black areas represent holes not covered by bars.

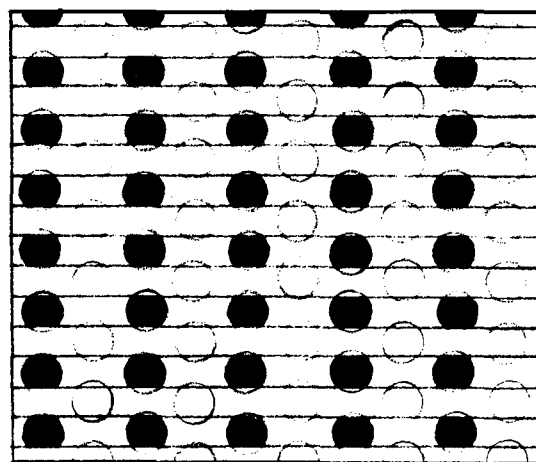
The above effect only occurs with the 4-mm bars since the spacing of the bars coincides with the 8-mm center-to-center distance between the holes, so the bars and the holes are in phase throughout the quadrant. With the other bars the distance does not coincide, producing a repeating pattern of the bars in and out of phase with the holes. This causes the discontinuous and staggered line pattern seen in two quadrants of Fig. 3. This pattern is similar to that described by Bonte and Dowdey with a line source phantom (1) although Fig. 10 shows that the cause of the pattern is different.

FIG. 9. The 4-mm bars in phase with rows of holes produce dark bands perpendicular to bars.

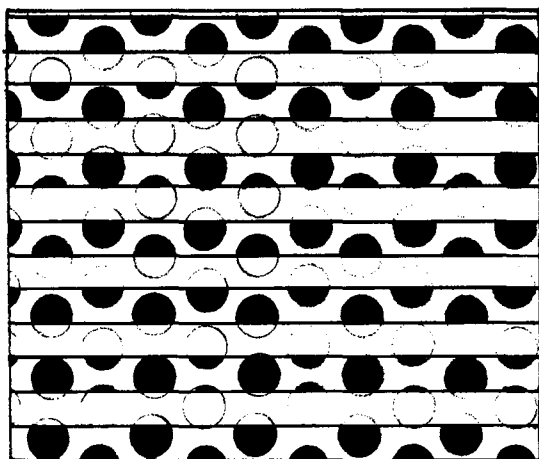
FIG. 10. The 4.5-mm bars in and out of phase with holes, producing discontinuous bands seen in Figure 3.

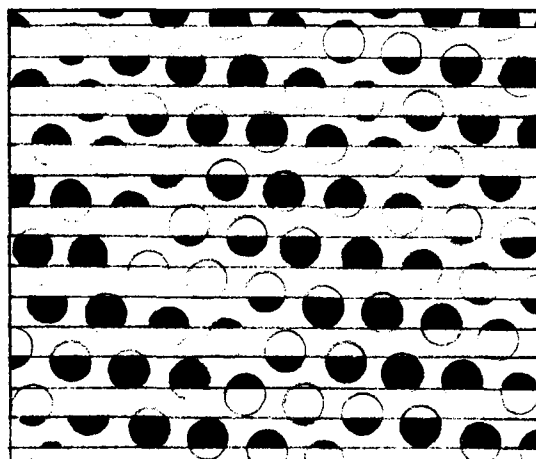
The fourth type of interference pattern (Fig. 11) occurs when the bars are at an angle to the rows of holes, causing the appearance of diagonal lines. A small change in the angle between the bars and holes causes a much larger change in the direction of the lines. This accounts for the

FIG. 11. Bars not parallel to holes form diagonal bands.

Several other collimators were tested with this bar phantom and one with larger bars. The interference patterns did not appear with low energy collimators, but were present whenever a medium or high energy collimator was used. Image aberrations occur because of the interaction between the bars and the hexagonal array of holes with thick septa. Suggestions for reducing or eliminating these image aberrations have been published (2, 3). These include: uniform rotation of the collimator while the image is being made; use of a pinhole collimator; use of low energy collimators whenever possible; and increasing

the collimator-to-object distance. In this particular case, however, when trying to determine the resolution of the camera with a high energy collimator, a different type of phantom or a different type of resolution test, such as full-width-half-maximum or modulation transfer function, is necessary.
