## Increasing awareness of a quality control problem in aging gamma cameras

### Abstract

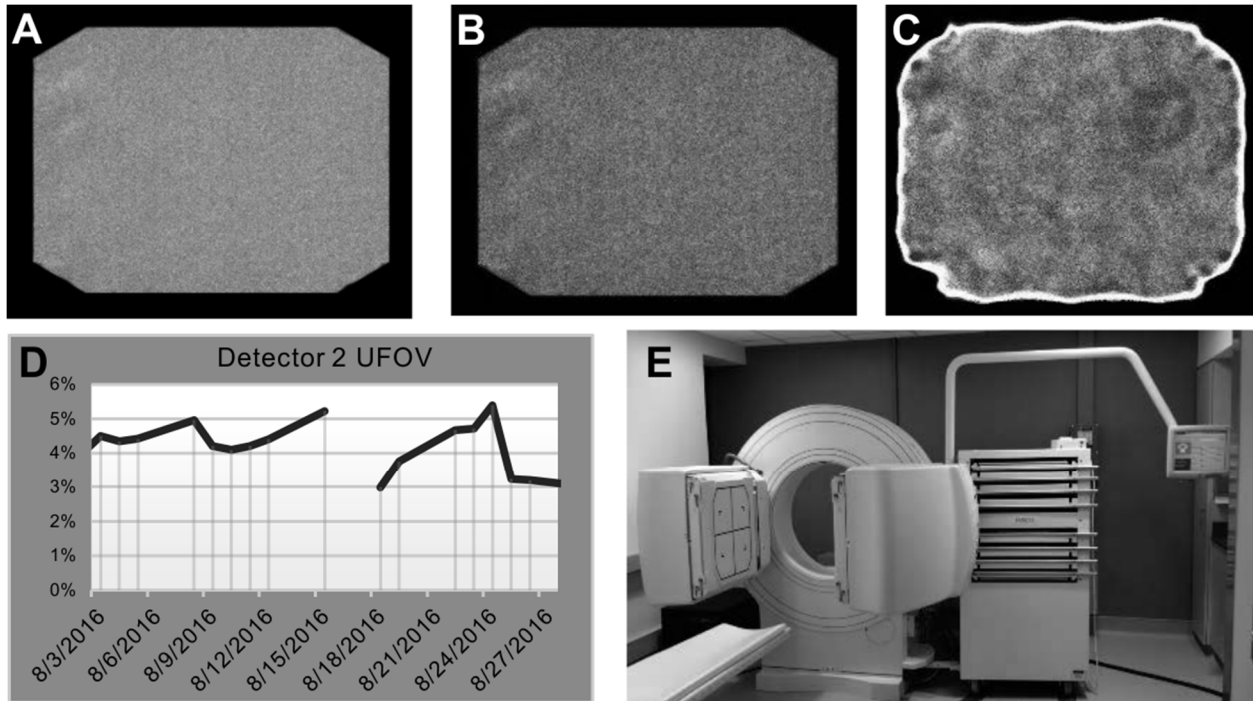
During daily extrinsic QC, it was discovered that detector two of a Philips Forte Anger style gamma camera had an integral uniformity field of view (FOV) value that was slowly increasing (Fig 1D) (5). Most of the rising values were not significant enough to raise alarm during QC as results were within the manufacturer recommendation of less than 5% deviation range. The manufacturer recommends that both intrinsic and extrinsic uniformity floods would be 15,000,000 counts at 20,000 to 50,000 counts per second for Epic detectors on the Forte (M. Schmidt, e-mail communication, January 4, 2019). This recommendation was followed by the department and this manuscript's figures include the total counts for each image. Once the 5% deviation range was reached, the scanner was taken out of service. Since the daily uniformity values had been increasing the past several days, the technologists kept watch on the QC and patient images to ensure no problems were present. This Forte (Fig 1E) had routine maintenance performed since its installation in 2003. Upon in depth QC image review, there was a photopenic circular image artifact noticed on the day the scanner was taken out of service (Fig 1A and 1B) which resulted in a call to the field service engineers.

Field service engineers performed intrinsic QC uniformity with the mask removed (Fig 1C) and discovered detector two would require a camera detector rebuild. A rebuild is disassembling the detector, cleaning the all the coupling gel from each of the PMTs and the crystal/light pipe assembly, then reapplying new coupling gel to the tubes and reinstalling them. A rebuild is necessary when the gel gets old or too hot and air bubbles get between the tube and light pipe or when tubes fail (M. Schmidt, e-mail communication, February 22, 2018) (5). As part of this rebuild, the service engineers tuned the PMTs. because of the cathode excitation; the service engineers predicted that a second or third tune might be necessary. Cathode excitation can

Figure 1: (A) Extrinsic Quality Control Uniformity, Detector 2 (D2), 08/15/2016, 15000K counts, Grayscale. (B) Extrinsic QC Uniformity, D2, 08/15/2016, 15000K counts, Thermal intensity increased to 91% (printed in grayscale). (C) Intrinsic QCU with mask removed, D2, 08/17/2016, 11706K counts, Thermal intensity at 12% (printed in grayscale). (D) Line graph of the daily integral Uniformity measurements of the useful FOV. (E) Image of the Philips Forte from VA Saint Louis Healthcare System John Cochran Division, St. Louis, MO. (3)

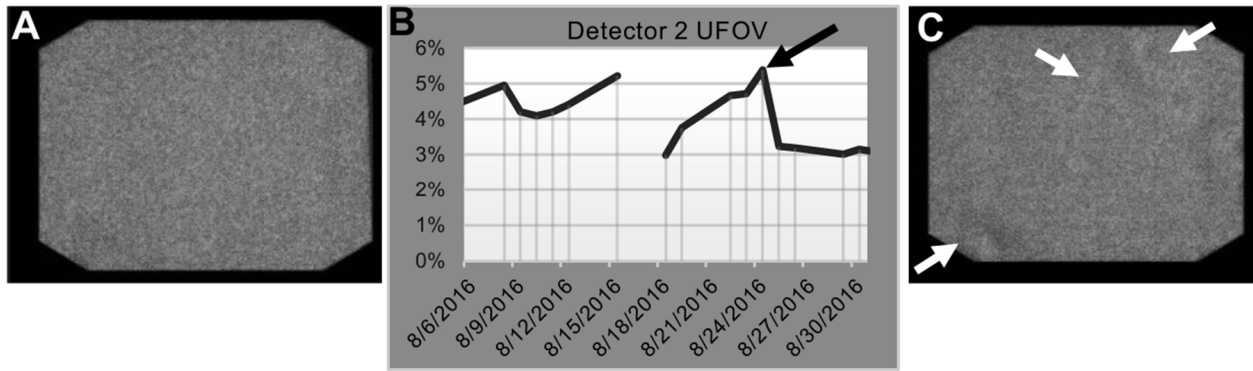
The service engineers took this scanner out of use to replace the defective coupling gel. Detector two was functional again two days later (5). The extrinsic QC imaging (Fig 2A) was satisfactory again, but a new artifact was introduced four days later (Fig 2C). The cause of this artifact was cathode excitation which required a tuning session (5). This artifact looked visually like the first artifact, so an untrained eye might perform another time-consuming rebuild with new gel when only tuning of the detector was required. The uniformity values were increasing again (Fig 2B) and it was operating outside the acceptable range. Service was once again called to assess the problem which resulted in another 1.5 days of service work (5). After this additional work of tuning the PMTs, service stated that another tune might be necessary in several days' time if the extrinsic QC increased. After four weeks the tubes had time to stabilize and the gel had time to set; it was determined a third tune was unnecessary (Fig 3C and Fig 3B solid arrow). After the second tune, an extrinsic flood showed uniform images (Fig 3A). When the extrinsic QC passed, an intrinsic flood was acquired to prove that a third tune was unnecessary (Fig 3C) (no extrinsic image included on this day). By this time, the values had normalized, and the image artifact was not seen.

Figure 2: (A) Extrinsic QC Uniformity, D2, 08/18/2016, 15000K counts, Thermal intensity at 91% (printed in grayscale). After detector rebuild. (B) Line graph of QC with arrow pointing to 08/24/2016 which was after the first rebuild which showed QC problems again. (C) Extrinsic QCU, D2, 08/24/2016, 15000K counts, Thermal intensity at 91% (printed in grayscale). Extensive modeling across the FOV due to PMT excitation; tune was done to remove the modeling. (3) Arrows indicate some mottling areas.

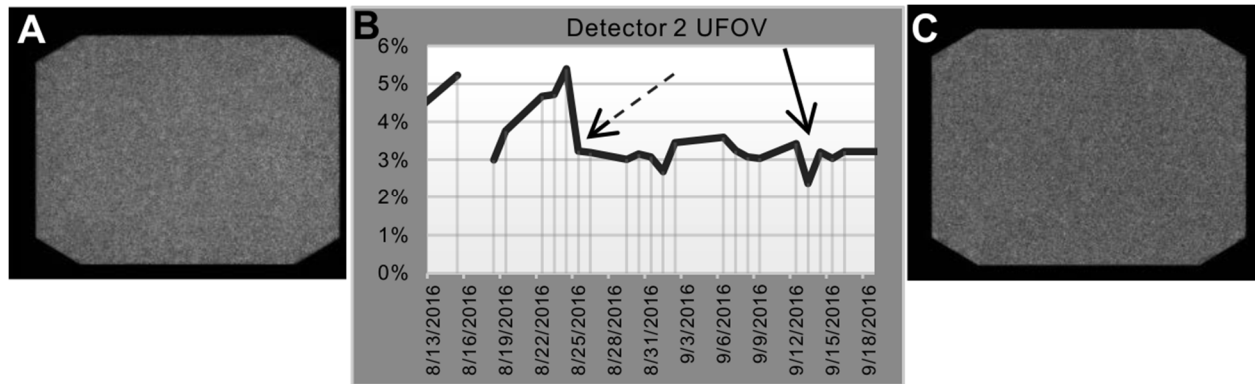
Figure 3: (A) Extrinsic QC Uniformity, D2, 08/25/2016, 15000K counts, Thermal intensity at 91% (printed in grayscale). After the second tune. (B) Line graph of QC with dashed arrow pointing to the extrinsic UFOV from 08/25/2016. The solid arrow is pointing to the extrinsic QCU from 09/14/2016 which is when D2 might have needed another tune. Another tune was not needed per our QC results. (C) Intrinsic QC Uniformity, D2, 09/14/2016, 15000K counts, Thermal intensity at 91 %. An extrinsic QC image was not captured on this day. (3)

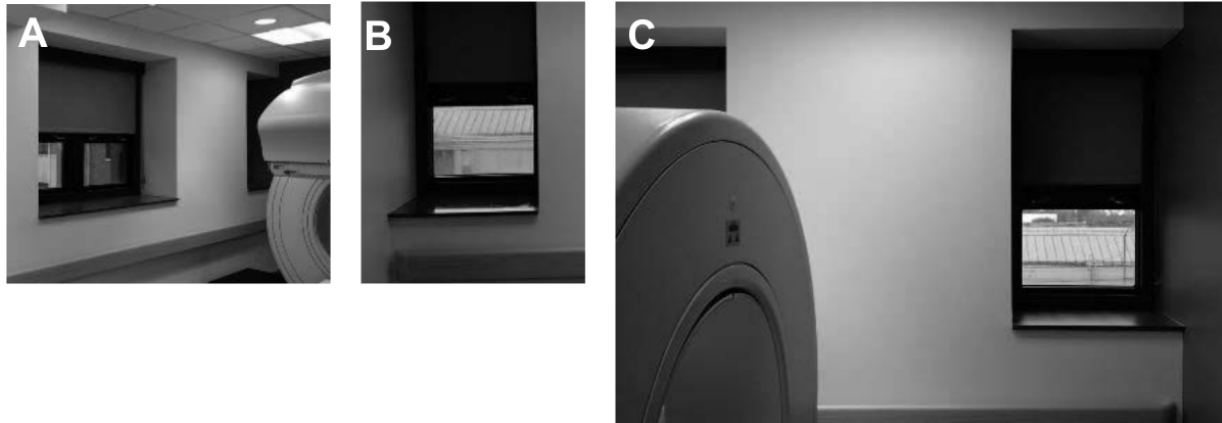
When a tube is exposed to even very low levels of ambient light, especially just before the tube is put into operation, the dark current in operation can initially be several orders of magnitude larger than that when the tube has stabilized several hours or even days in darkness.

The pulse height spectrum is similar to that for single photoelectrons. This phenomenon is very dependent on the cathode substrate. In normal use, take simple precautions to limit exposure. In all cases, avoid fluorescent light and daylight.

Figure 4: (A) Image of windows and ceiling with fluorescent light in the Philips Forte gamma camera room. (B) Additional window (C) Third window. (3) (D) Excerpt from the Photonis Photomultiplier Tube (PMT) manual. (5)

When determining the quality of the image acquisition on a gamma camera, aging equipment may lead to unexpected QC concerns. During a detector rebuild on a gamma camera, it may be important to work in specific lighting conditions. Performing the recoupling without ambient light and giving ample time for the gel to set is more advantageous for fewer scanner down days. This scanner ended up being out of service for a total of four days. After the rebuild of this detector, the integral and differential values on daily QC must be closely monitored (5). If these steps are not taken, the gel may not have time to set or the electronic voltage may drift, and
