A Method to Assess Collimator Integrity

Don Beyea and Debbie Boudreau

Nuclear Medicine Department, Saint John Regional Hospital, Saint John, New Brunswick, Canada

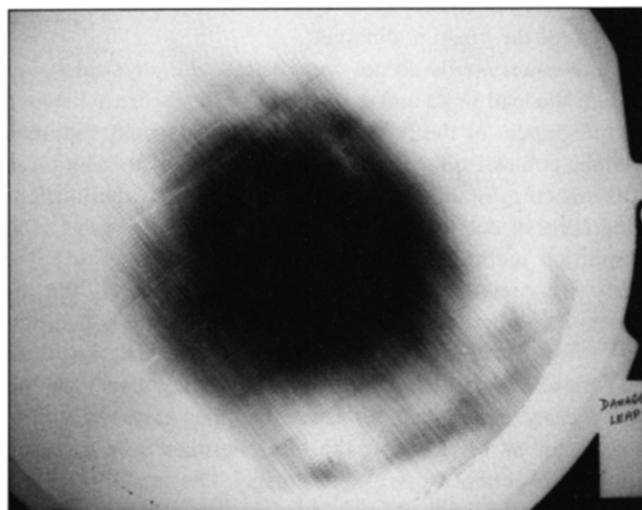
FIGURE 2. Conventional x-ray image of damaged collimator.

Figure 2 shows a conventional x-ray image of a damaged low-energy all purpose (LEAP) collimator. Although gouged septa are visible, only a portion of the collimator face can be analyzed. Most of the holes are not visualized as hexagonal channels (because the x-ray beam is divergent) and the intensity of the image varies from being too black to too white. Figure 3A shows a bone densitometry image of this same damaged collimator. Figures 3B and C show detailed enlargements of sections of the image shown in Figure 3A. Figure 4A shows the structurally intact LEAP collimator, while Figure 4B is a detailed enlargement.

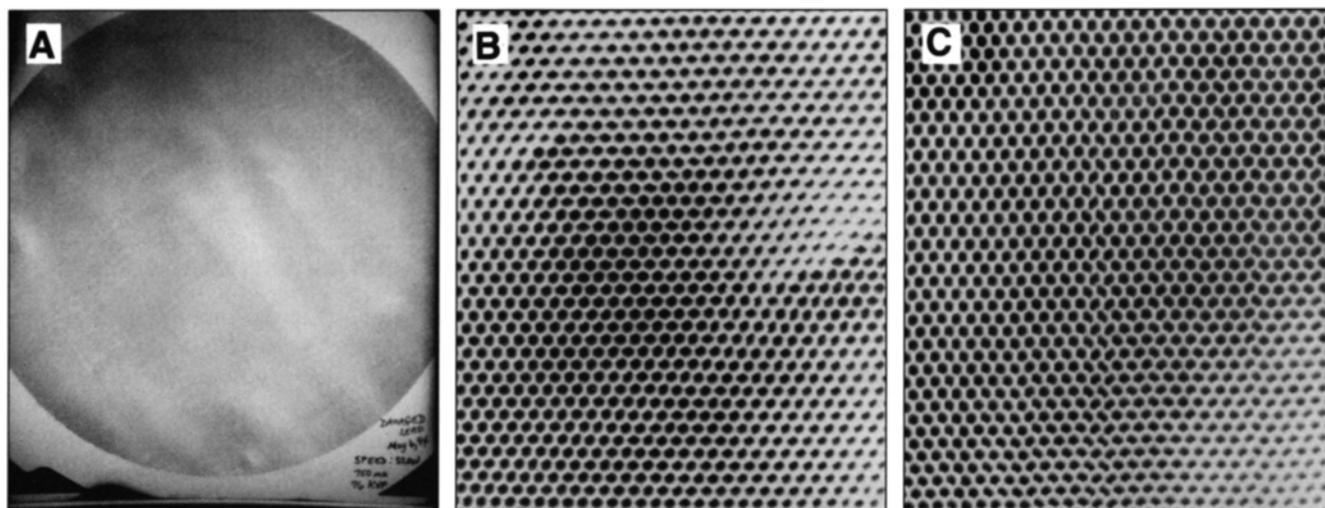
FIGURE 3. (A) X-ray densitometry image of damaged collimator. (B, C) Detailed enlargements of two sections of the damaged collimator.

The advantage of the parallel x-ray beam is evidenced by the visualization of more of the hexagonal channels, except for those damaged channels where gouging occurred and the lead foil was folded over. The images are so clear that even measurement of the holes and the septa is possible. When the bone densitometry image of the damaged collimator is compared to an actual photograph of the collimator (Fig. 5), the large gouges seen on the surface of the collimator correlate with defective areas seen on the densitometry image, along with many other scrapes and indentations not observed on the outside covering of this collimator.

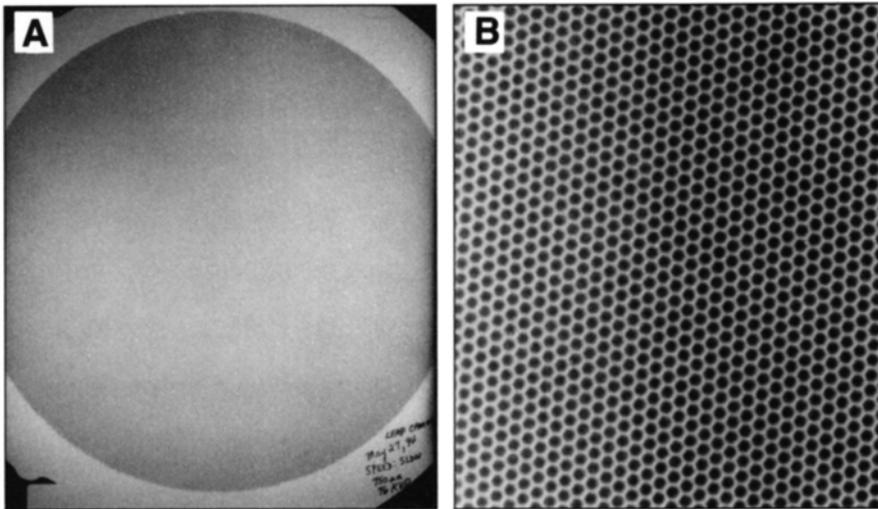
FIGURE 4. (A) X-ray densitometry image of intact collimator. (B) Detailed enlargement of a section of the intact collimator.

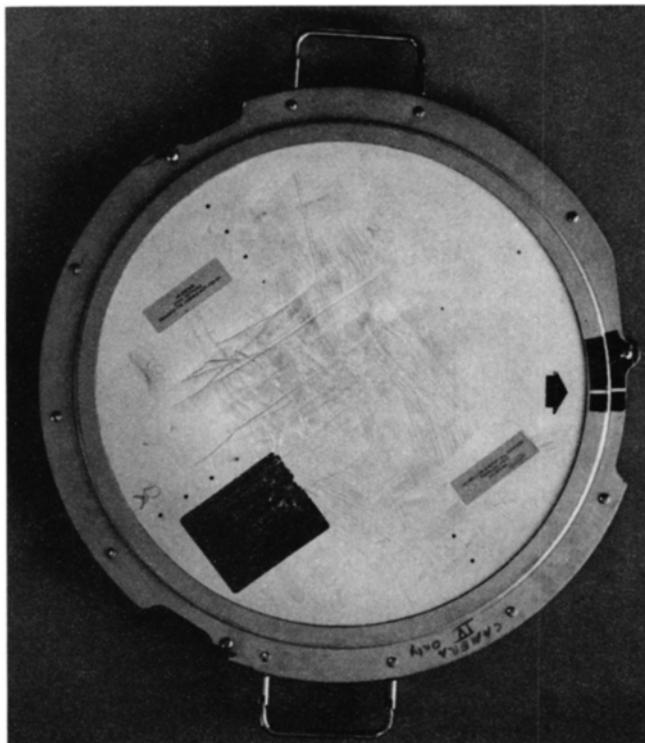
FIGURE 5. Photograph of damaged collimator.
