## The "Breast-Pocket" Sign: A Clue to the Possibility of Spurious Radionuclide Uptake: A Case Report

J Nucl Med Technol 1994; 22:211-212

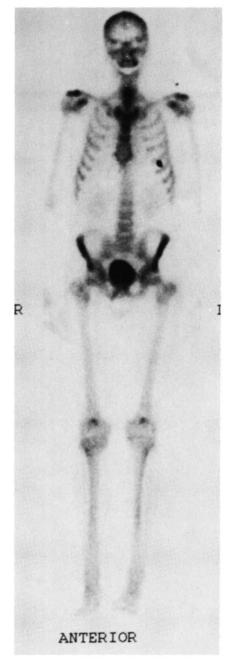
FIGURE 1. Antewhole-body bone scan image 3 hr after the intravenous administration of 25 mCi of 99mTc-MDP demonstrates a focus of increased activity seemingly within the left anterior fifth rib. Commonly observed uptake within the joints was the only other finding.

A 52-yr-old male underwent <sup>99m</sup>Tc-MDP whole-body bone scanning to evaluate lumbar back pain. This examination demonstrated a single focus of activity seemingly within the left anterior ribs, suggesting rib fracture or, much less likely, occult metastases.

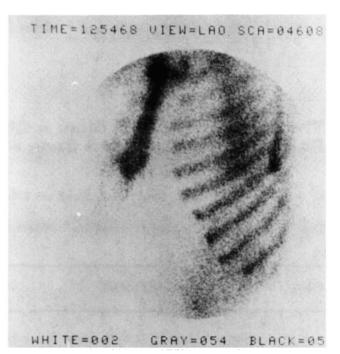
FIGURE 3. Left anterior oblique projection image after speaking with the patient and removing his shirt breast pocket contents demonstrates the elimination of activity in this same region. The patient had removed his injection site bandage, placing it within his shirt breast pocket 1 hr after the intravenous administration of radionuclide.

Closer inspection of the images showed the activity to be between, rather than within, ribs. Examination of the patient revealed a blood-stained (and radionuclide laden) bandage within the shirt breast pocket, which when removed, caused the elimination of the chest wall activity previously noted. This is an example of how close inspection of the images, and patient contact, can sometimes clarify potential artifact.
