# Use of SPECT/CT with $^{99m}\text{Tc}$ -MDP Bone Scintigraphy to Diagnose Sacral Insufficiency Fracture

Bone SPECT/CT offers additional information on pelvic insufficiency fractures, especially when there is incomplete formation of the H-sign on planar bone scanning.

**J Nucl Med Technol 2014; 42:240–241**

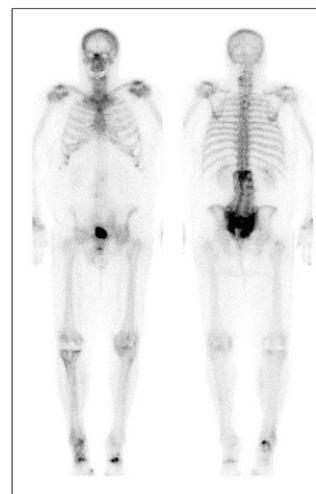
**FIGURE 1.** Anterior (left) and posterior (right) whole-body bone scan images showing classic H-sign in posterior view of pelvis. Some postoperative changes are noted in lumbar screws and right knee prosthesis, and degenerative changes are also seen in cervical spine and appendicular joints.

A 74-y-old man with a history of L1 through L4 laminectomy and fusion within the past year who had undergone high-dose brachytherapy for prostate cancer 2 y ago presented with complaints of lower back pain for the past 3 mo. There was no reported history of a traumatic event. A bone scan was ordered to evaluate the cause of the pain. After intravenous administration of 1,010 MBq (27.3 mCi) of  $^{99m}\text{Tc}$ -medronate, anterior and posterior whole-body bone scans were obtained. SPECT/CT imaging was also performed to include the regions of the lumbar spine and sacrum. The bone scan and SPECT/CT images showed vertical linearly increased uptake in the medial to bilateral sacroiliac joint and horizontal increased uptake connecting the vertical lines (H-shaped uptake) in the sacral region (Figs. 1 [planar bone scan] and 2 [SPECT/CT bone scan]).

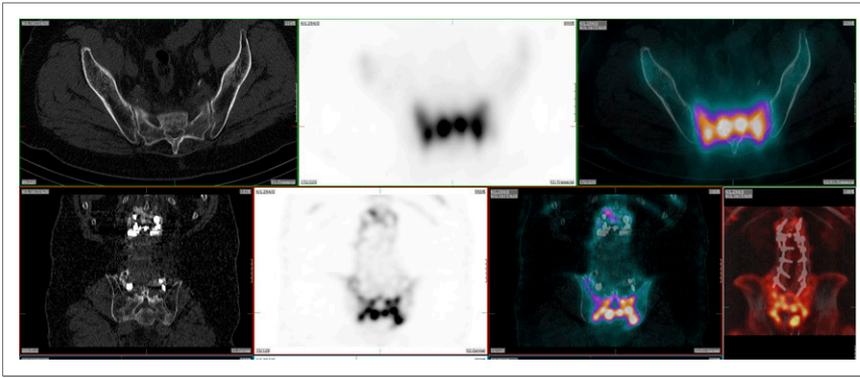
**FIGURE 2.** CT, SPECT, SPECT/CT images including lumbar spine region and sacral region area. In top row, from left to right, axial CT shows normal findings and corresponding SPECT and fused SPECT/CT images show intense bone uptake. In bottom row, from left to right, screws are seen on coronal CT, corresponding intense pelvic uptake is seen on SPECT and fused SPECT/CT, and spinal screws are seen on fused SPECT/CT.
