DOSE CALIBRATOR PERFORMANCE AND QUALITY CONTROL

MORE ON DOSE CALIBRATOR PERFORMANCE

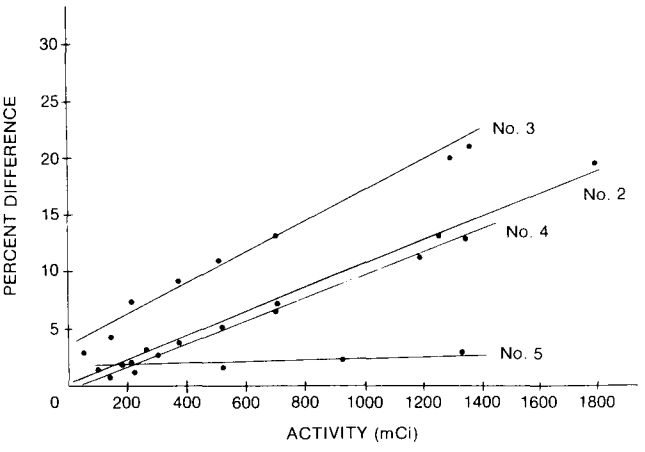
Our primary calibrator (Table 1, No. 1) has proved over a period of a year and a half to provide a linear response up to 1.8 Ci of activity. Since the other calibrators exhibited variation, a comparison of whole-vial generator eluates was undertaken between calibrator No. 1 and each of the other calibrators. The percent difference for each is graphically illustrated in Fig. 1. In all cases the readings were lower than for calibrator No. 1.

It is interesting to note that ionization chambers with Capintec lot designation "T" all exhibited marked nonlinearity, especially in the high-activity range. The two "R"-lot chambers remained linear throughout a wide range of activity showing less than 3% variation. We brought this information to the attention of personnel at

FIG. 1. Comparative calibrator assay of whole-vial generator eluate.

Capintec, who stated that apparently an impurity was present in the gas of the T-lot chambers which caused the nonlinearity. Because of this, we currently use only the R-lot chambers.

We would caution departments receiving a new calibrator to study the linearity of the machine over the total range of the department's activity usage. This can be accomplished by comparative assay if another calibrator is available and known to be linear, or by the concentration-volume method mentioned by Kowalsky et al. (*1*). A probelm with the concentration-volume method is the fact that saline reservoir generator systems provide a different elution volume each time. This can be overcome by using the weighing technique described by Benedetto (*2*).
