Foil Collimator Defects: A Comparison with Cast Collimators

Michael J. Blend, Bhupendra A. Patel, Darius Rubas, Carlos Bekerman, and Ernest Byrom

Humana Hospital-Michael Reese, Chicago, Illinois and The Evanston Hospital, Evanston, Illinois

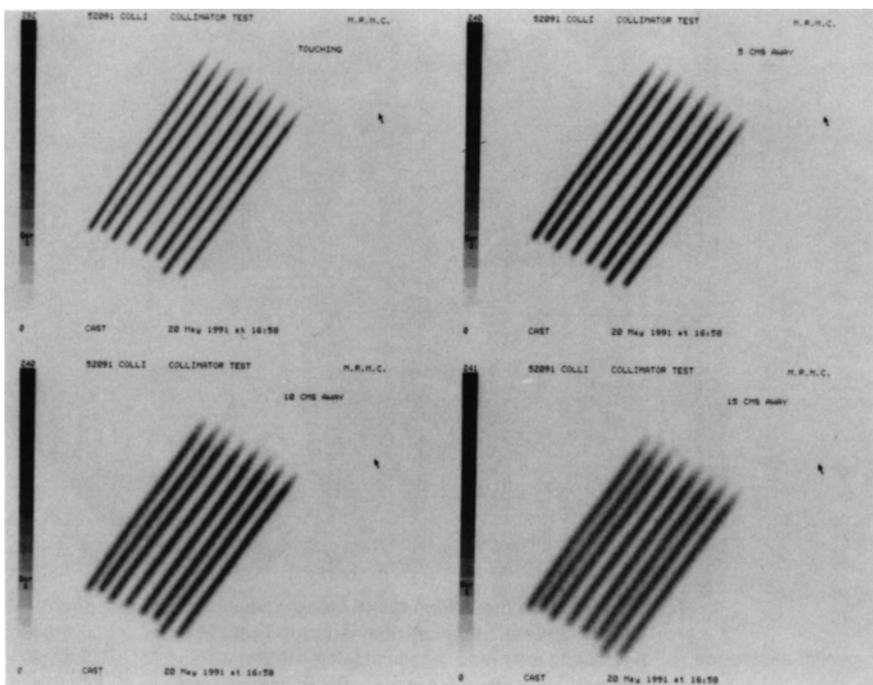
The line sources were set diagonally in the field of view to avoid alignment with the defects. Visual inspection reveals horizontal streak artifacts crossing the diagonal line images at 15, 20, 25, and 30 cm from the camera face with the foil collimator (Fig. 4). No artifacts are seen in the cast collimator images (Fig. 5).

FIG. 5. Multiple planar images of line sources at 0, 5, 10, and 15 cm from face of camera using cast collimator. No defects are seen.

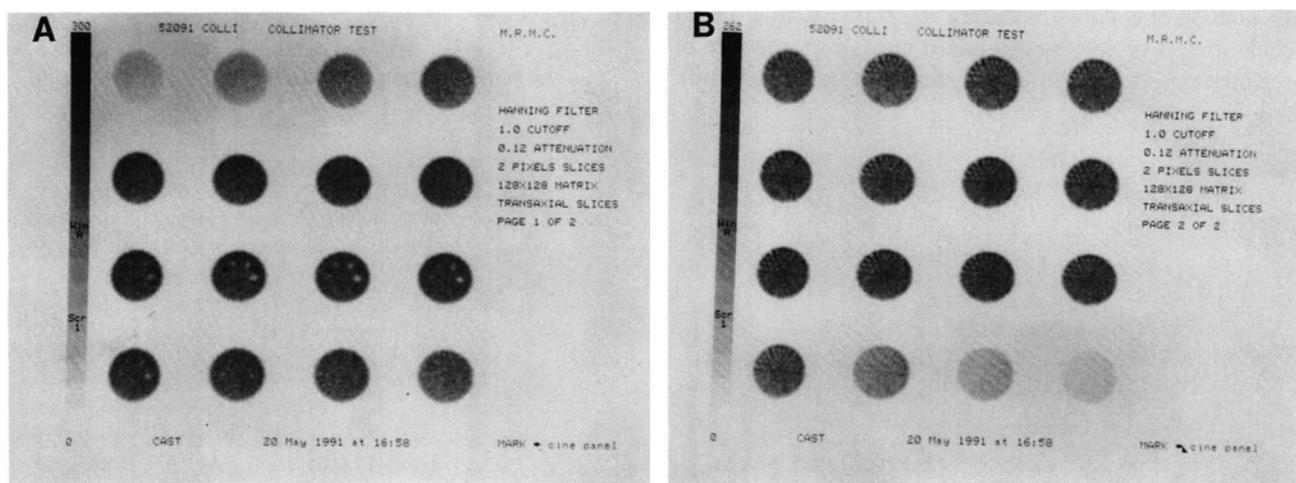
FIG. 7. Multiple transaxial slices of SPECT images using cast collimator. Note absence of ring artifacts.

slices through a SPECT phantom filled with a solution containing 10 mCi of ^{99m}Tc . Note the ring artifacts in slices 1–3, 22–23, and 26–32 in the transaxial sections of the phantom, when using the foil collimator. These artifacts were observed on five separate occasions with two different GE SPECT gamma camera systems. The defects are more apparent on the images reconstructed after prefiltering (Fig. 6). There are no ring artifacts when the cast collimator is used (Fig. 7).
