# Instrumentation

## Troubleshooting Nuclear Medicine Instrumentation Problems

*Because the ultimate goal of any nuclear medicine procedure is to obtain diagnostically reliable images in the most cost-effective manner, troubleshooting of instrumentation problems is an integral part of this specialty. Many instrumentation problems can be rectified without serviceman intervention by the technologist who has proper knowledge of the equipment involved. An outline of common equipment problems and a systematic scheme for diagnosis and rectification of these problems are presented.*

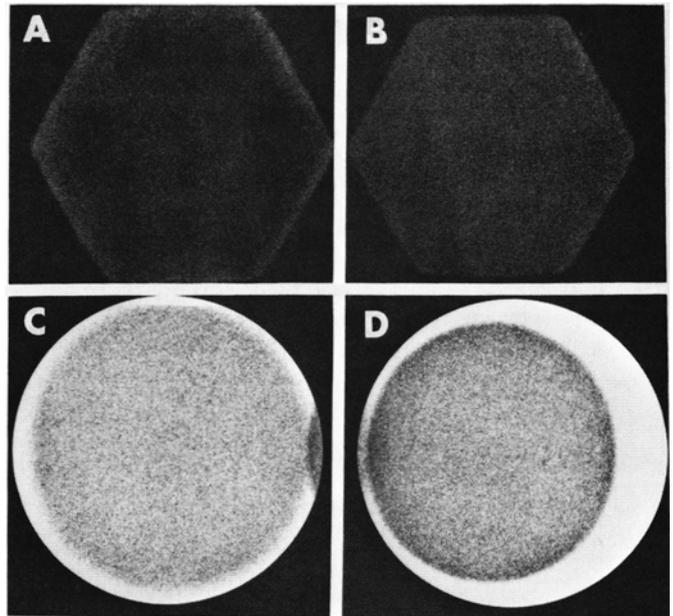
**FIG. 1.** Effect of mis-peaking and incorrect flood source on field flood uniformity. (A) Gross, striking nonuniformity is seen when a Co-57 flood is erroneously peaked on TI-201 settings. (B) Correctly peaked field flood. (C) Flood performed with high activity demonstrates spatial distortion and blurred contours. (D) Flood obtained with appropriate source.

An incorrect photopeak setting will present nonuniformities characteristic of the scintillation camera involved. On some camera systems, nonuniformities can be striking because photomultiplier tube differences are enhanced at off-peak settings. With the advent of uniformity field correction devices, correct peak adjustments for the daily flood is especially important; this flood pattern is stored in memory and used to correct subtle voltage drifts throughout the course of the day. If a multichannel analyzer is available on the camera system, peak the camera with this device since it is most accurate (5). Double check the peak setting with the spectrum or ratemeter controls to counter-check proper peak adjustment (Fig. 1).

a uniform distribution of radioactivity. Bubbles within the source or an unevenly distributed mixture can result in a nonuniform field flood image. Also, when source activity is too intense, whether it be with the commercially available Co-57 or daily prepared Tc-99m sources, nonuniformities and apparent loss of resolution will result (Fig. 1).

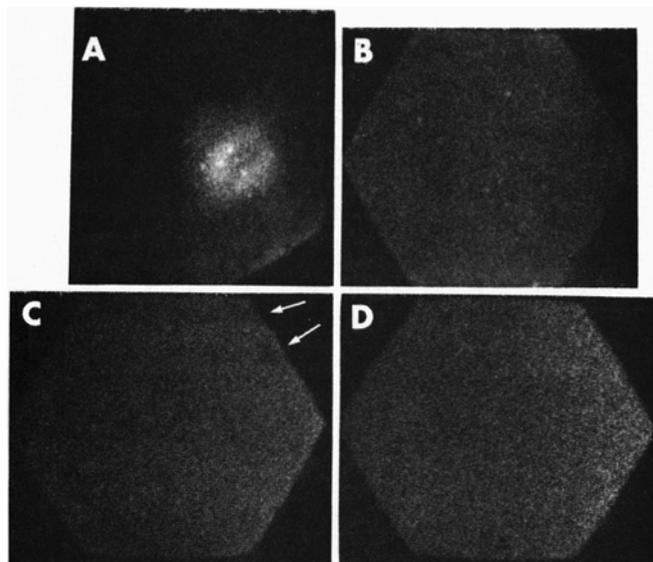
**FIG. 2.** (A) Thallium-201 study performed on a camera with crystal hydration. (B) Associated Tl-201 field flood. (C) Field flood performed at room temperature of  $80 \pm 3^\circ$ . (D) Field flood performed at room temperature of  $70 \pm 2^\circ$ .

Figure 2 shows a Tl-201 scan performed in our department with some unusual hot spots noted. These anomalies were not seen on Tc-99m scans nor on the Co-57 quality control field flood image. Only when field floods or studies were performed with Tl-201 were they present. The serviceman confirmed moisture deposition within that portion of the crystal closest to the aluminum housing, the part where lower energy gamma interactions occur. Installation of a new crystal corrected the problem (6). Field flood examinations with Au-195, a simulated Tl-201 source, is a useful adjunct to the routine Co-57 field flood in our laboratory to detect possible early recurrence of a problem of this nature. If an operating environment becomes too hot or humid, every effort should be made to remove the equipment from the area or change the abnormal condition within the area by means of portable fans until it can be permanently stabilized. Once the environment has been properly stabilized, daily work can be resumed after repeating quality control measurements.

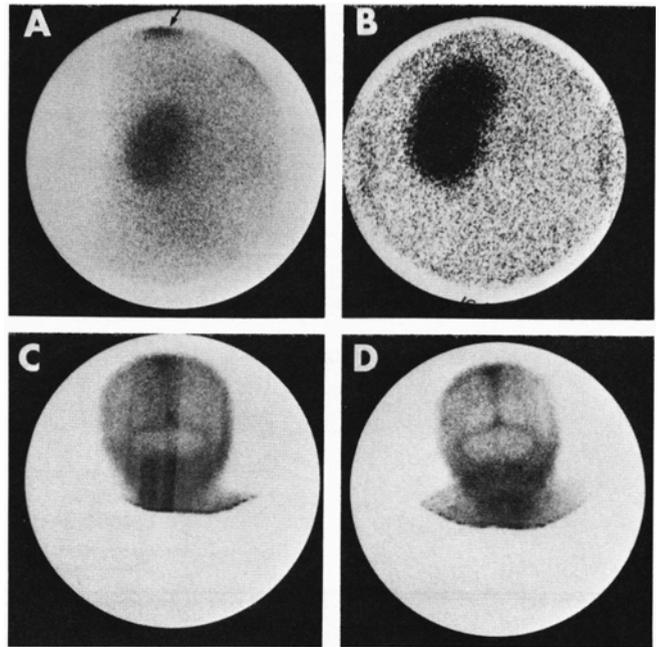
**FIG. 3.** (A) Surface contamination on inside of collimator noted on encephalogram study. There is image degradation caused by uncollimated scatter from the contaminating source (arrow). (B) Same study on a different camera/collimator system. (C) Processor roller artifacts noted on brain image. (D) Repeat image after processor rollers were cleaned.

possibility of contamination within the external imaging area. Removing the collimator and performing an uncollimated field flood will determine whether the source of contamination is on the collimator or on the crystal housing. Cleaning the crystal housing or collimator and locating and removing the external source will correct the image distortion on repeat images (Fig. 3 A and B).

Developer streaks caused by unevenly distributed film emulsion and film processor streaks can simulate nonuniformities on both Polaroid and transparency images. These problems can usually be detected by visual inspection of the image. Clean the camera or processor rollers to rectify the problem (Fig. 3 C and D).

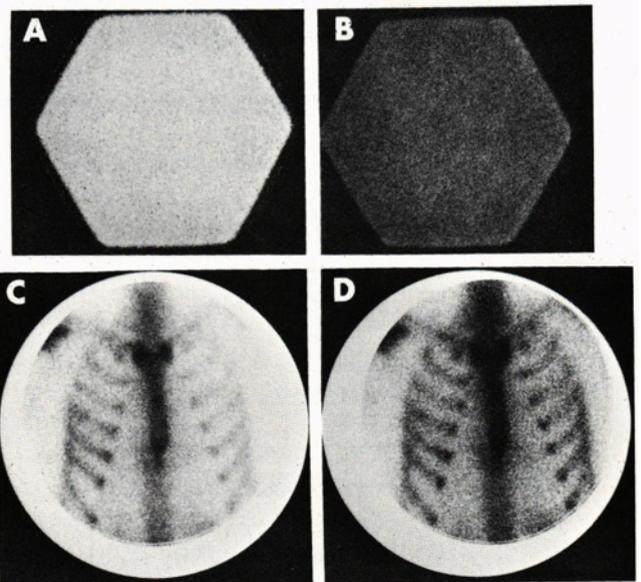
**FIG. 4.** (A) A field flood at f-stop of 8 for 500,000 counts results in overexposed image. (B) A field flood at an f-stop of 11 for 500,000 counts results in a properly exposed image. (C) Improper retraction of the multi-imager lens filter causing left chest to appear lighter. (D) Repeat images after filter is completely retracted.

Over or underexposed photographs are usually the result of the f-stop setting being inadvertently in an incorrect position. This occurs most frequently in equipment used in a portable mode. Check the f-stop position and move it to the appropriate setting (Fig. 4).

For transparency images on multi-imager units, a light calibration device needs to be adjusted each time a new intensity factor is dialed in. Failure to do so will result in improperly exposed transparency studies. Some multi-imager systems also have a flip-switch that introduces a filter across the multi-imager lens face to permit light filtering for proper image exposure. These filters will sometimes only partially move in or out of place or not retract at all, creating image exposure problems. If permitted in your service contract, enter the multi-imager unit and check for proper switch function. Oftentimes this malfunction can be easily corrected by a simple adjustment (Fig. 4).

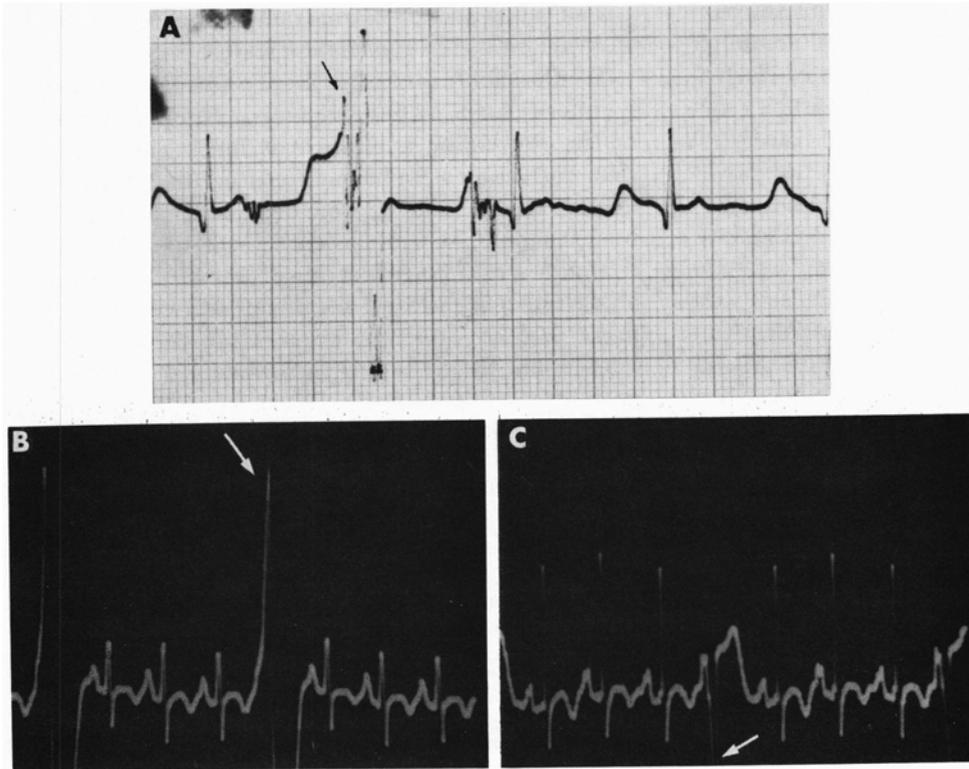
**FIG. 5.** (A) Effect of ECG electrode placement. Artifact (arrow) is caused by a loose electrode. (B) Frequent PVCs (arrow) are magnified by electrode placement. (C) Reversal of leads and change of electrode placement changes the polarity of the PVCs (arrow).

Self-adhering electrodes can become loose during a gated study due to perspiration or oily skin surface, particularly in exercise studies. Loosened electrodes can produce artifactual spikes on the ECG tracing, which can be misinterpreted as an R-trigger by the computer. Continuation of the study under these circumstances will result in erroneous ejection fraction determination. Prior to attaching the electrodes to the patient, clean the area thoroughly with alcohol and wipe completely dry. Apply the electrodes firmly to the cleaned areas and check them at periodic intervals during the course of the study to ensure proper electrode-skin contact (Fig. 5).

Electrodes must be placed in such a manner as to obtain the best QRS complex on the ECG tracing. Moving an electrode closer to the heart can improve the amplitude of the QRS complex resulting in better separation between the R- and T-waves. Changing the gain control on the instrument will amplify the QRS complex for a better tracing. Changing electrode polarity is oftentimes necessary to invert high spikes due to interference caused by premature ventricular contractions. Changing polarity to a negative mode inverts the premature ventricular contraction spike and it is no longer

interpreted by the computer as an R-trigger (Fig. 5). Artifacts on ECG tracings due to respiratory movement are also enhanced during exercise studies. This problem can be minimized by moving the left lateral electrode away from the diaphragm and more towards the midline of the body.
