Use of SPECT/CT with ^{99m}Tc -MDP Bone Scintigraphy to Diagnose Sacral Insufficiency Fracture

Bone SPECT/CT offers additional information on pelvic insufficiency fractures, especially when there is incomplete formation of the H-sign on planar bone scanning.

J Nucl Med Technol 2014; 42:1-2

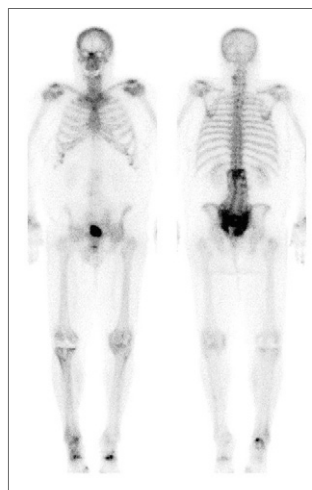
FIGURE 1. Anterior (left) and posterior (right) whole-body bone scan images showing classic H-sign in posterior view of pelvis. Some postoperative changes are noted in lumbar screws and right knee prosthesis, and degenerative changes are also seen in cervical spine and appendicular joints.

[Fig. 1] horizontal increased uptake connecting the vertical lines (H-shaped uptake) in the sacral region (Figs. 1 [planar bone scan] and 2 [SPECT/CT bone scan]).

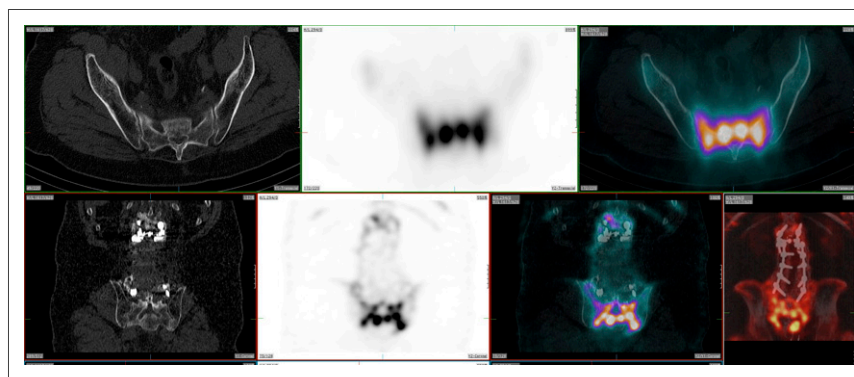
FIGURE 2. CT, SPECT, SPECT/CT images including lumbar spine region and sacral region area. In top row, from left to right, axial CT shows normal findings and corresponding SPECT and fused SPECT/CT images show intense bone uptake. In bottom row, from left to right, screws are seen on coronal CT, corresponding intense pelvic uptake is seen on SPECT and fused SPECT/CT, and spinal screws are seen on fused SPECT/CT.
