A Simple Solution to Prevent the Loss of Radioactive Spot Markers

Key Words: cobalt-57 spot markers; radioactive spot markers

J Nucl Med Technol 2000; 28:45-48

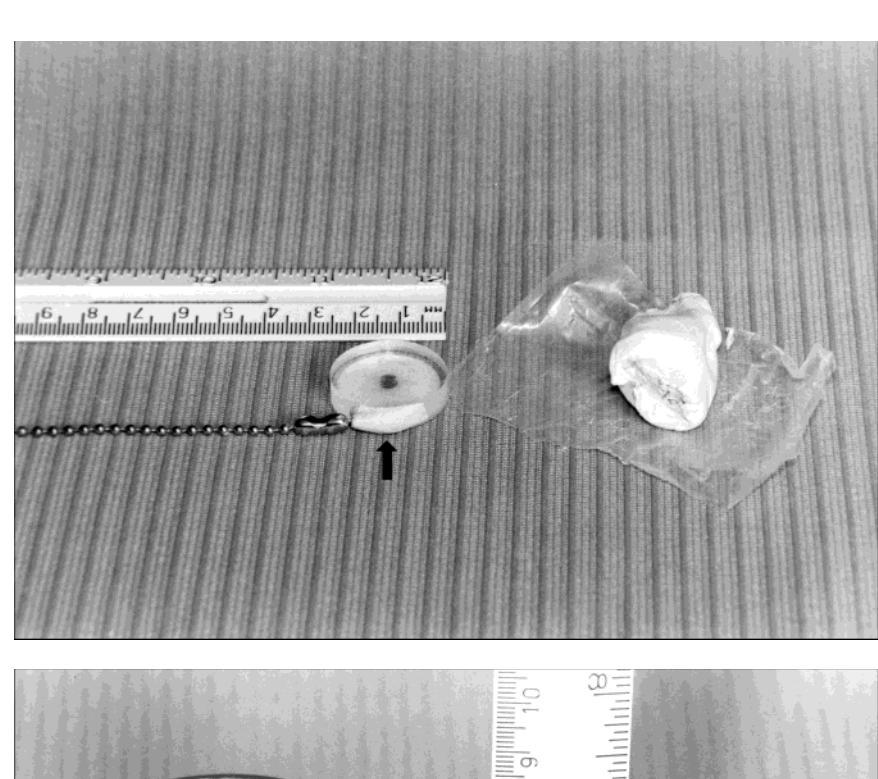
FIGURE 1. A small amount of flexible plastic repair putty (right) was used to cover four beads (arrow) of a metallic chain that were placed on the side of a ⁵⁷Co spot marker. After several hours the repair putty hardened, securing the marker to the chain. If necessary the beaded chain can be removed from the ⁵⁷Co spot marker at the beaded chain connector, placed close to the marker.

One end of an approximately 90-cm long, 2-mm round metallic beaded chain was attached to the side of a ⁵⁷Co spot marker using flexible plastic repair putty (Fig. 1) that was allowed to harden. A 5-mm thick piece of acrylic was attached to the bottom of a lead radiopharmaceutical shield (e.g., ²⁰¹Tl, ⁶⁷Ga). The acrylic was cut to cover the bottom of the lead shield and to have a small upturned lip on one side (Fig. 2). The other end of the beaded chain was passed through a small drilled hole in the upturned lip and secured using a beaded chain connector (Fig. 3). A notch for the beaded chain was placed in the top of the lead shield (Fig. 3) to permit the lead cap to fit securely while the ⁵⁷Co spot maker is stored in the shield when not in use.

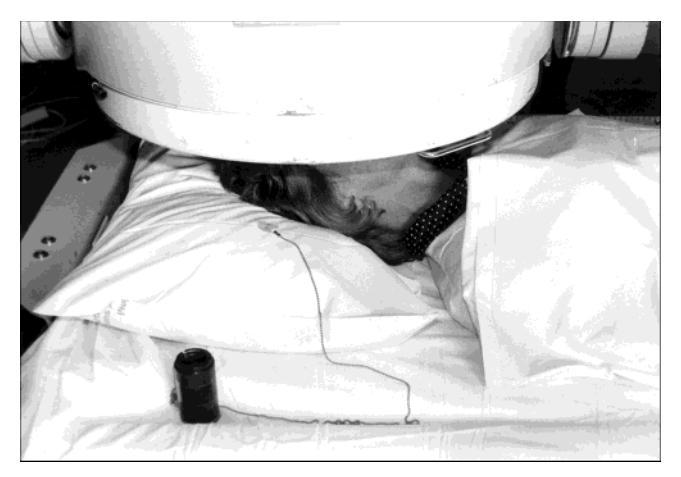
FIGURE 3. The other end of the beaded chain that was attached to the ⁵⁷Co spot marker was passed through a small drilled hole in the upturned lip. The chain was secured with a beaded chain connector (open arrow). A small washer between the connector and the lip was used so that the connector would not slip through the hole. A notch for the beaded chain was placed on the top of the lead shield. This allows the lead cap to fit securely on the lead shield when the ⁵⁷Co spot marker is not in use.

All the materials required, except for the lead shield that the nuclear medicine department had available, were found in our hospital's engineering department. They should be available also through a hardware store. Our engineering staff cut the acrylic, formed an upturned lip by gently heating and bending the acrylic, and drilled a hole in the upturned lip. They attached the acrylic to the lead shield. We were able to complete the assembly by connecting the beaded chain to the ⁵⁷Co spot marker and the lead shield.

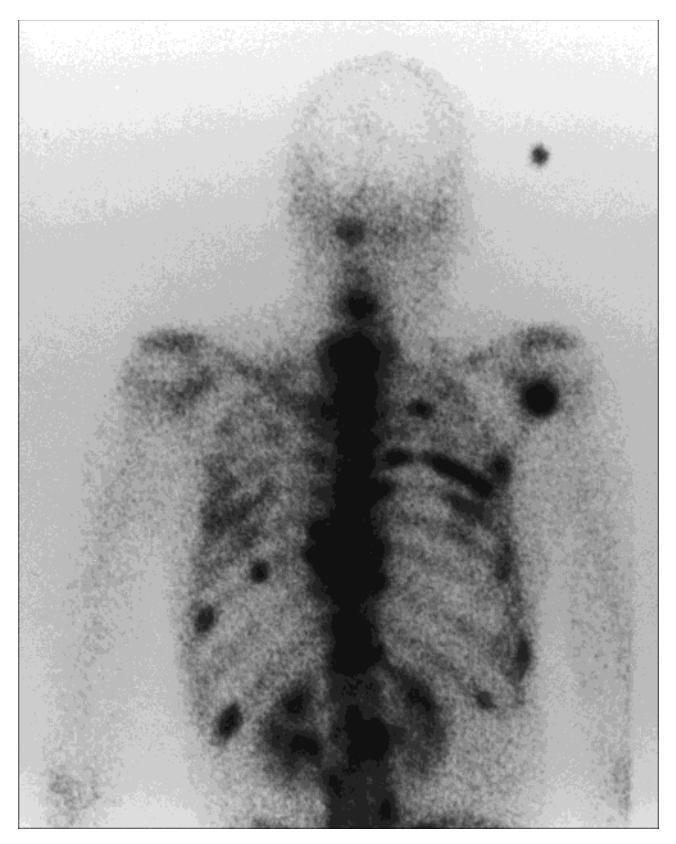
FIGURE 4. The ⁵⁷Co spot marker is placed next to the patient to mark the patient's right side on this scan. The chain is long enough so that the lead shield can be placed at the patient's side on the imaging table.

When the 57 Co spot marker is in use, the lead container is placed on the imaging table next to the patient while the spot marker is placed on or next to the patient (Fig. 4). This design has allowed unobstructed use of the 57 Co spot marker for marking the right or left side (Fig. 5) and anatomical position (e.g., thyroid nodule (Fig. 6) (*3*), suprasternal notch, umbilicus, etc.) while preventing its loss. Typically, when a spot marker view is used, the view is repeated without the marker(s). This eliminates any concern about the minimal attenuation caused by the metallic beaded chain in the spot marker view though it
