# Brain SPECT Artifacts in Patients Having Metallic Cranioplasty

Michael T. Hackett, Wei-Jen Shih, and Vickie H. Kiefer

*Radiation Safety Office and Nuclear Medicine Service, Department of Veterans Affairs Medical Center, Lexington, Kentucky*

*J Nucl Med Technol 2001; 29:189–192*

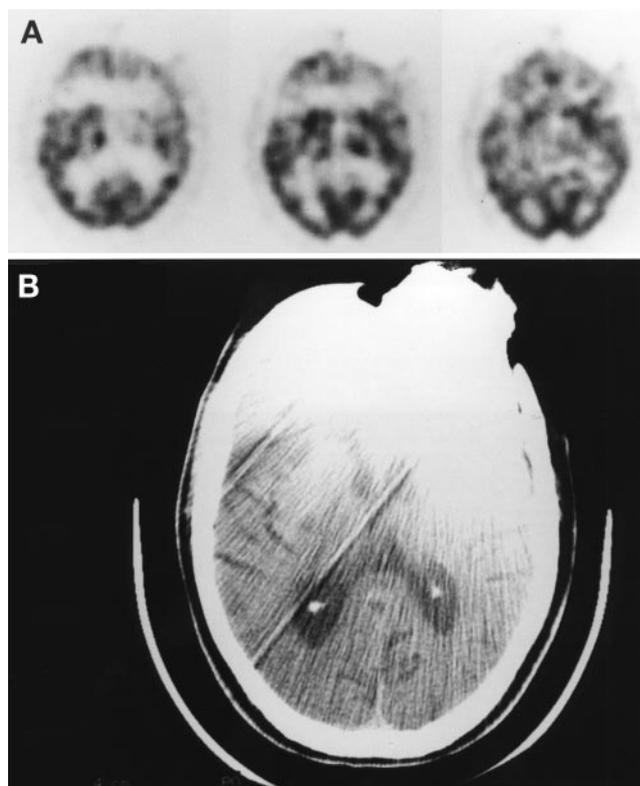
**FIGURE 1.** Patient 1, with head trauma in the 1940s that required a metallic plate in the left frontal area. (A) Transaxial images from brain SPECT study show photon-deficient area in the left frontal region with faint increased tracer activity extending into scalp area at periphery. (B) CT shows significant streak artifact caused by the metallic plate.

The patient brain SPECT transaxial images (Figs. 1A, 2A, 3A) showed a photon-deficient area underlying the metallic plate with increased tracer activity at its periphery that extended into the area of the scalp. Patient CT studies (Figs. 1B, 2B, 3B) showed significant streak artifact caused by the metallic plate.

The SPECT brain phantom studies with the lead sheets clearly showed a defined photon-deficient artifact. An area of increased tracer activity was also evident at the periphery of this photon-deficient artifact. This increased tracer activity is also an artifact because it extends beyond where any activity should be found. These artifacts are caused by photon attenuation by the metallic plate, which results in SPECT reconstruction errors. These artifact presentations are similar to our patient studies, though one cannot assume that the photon-deficient areas in the patients were solely a result of attenuation from the metallic plates because they have had head trauma to these areas. These studies still yielded clinical information of perfusion in other regions of the brain unaffected by the artifacts. A similar brain SPECT artifact caused by a metallic plate can be seen in the case presentation by Boren et al. (5,6). Although we cannot confirm that the patients we studied had tantalum plates, the surgical literature states that tantalum (1) plates are radiopaque, and contains reports of CT studies that are similar to our patients' CT studies (Figs. 1B, 2B, 3B). The literature (1-3) also states that both aluminum and stainless steel

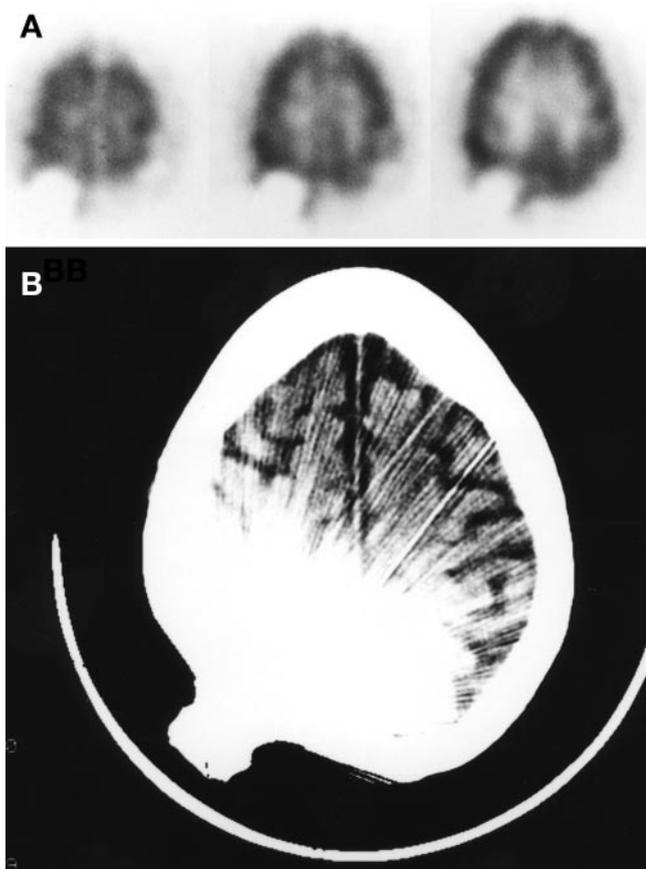
**FIGURE 2.** Patient 2, with head trauma in the 1970s that required a metallic plate in the right occipital area. (A) Transaxial images from brain SPECT study show photon-deficient area in the right occipital region with prominent increased tracer activity extending into scalp area at periphery. (B) CT shows significant streak artifact caused by the metallic plate.

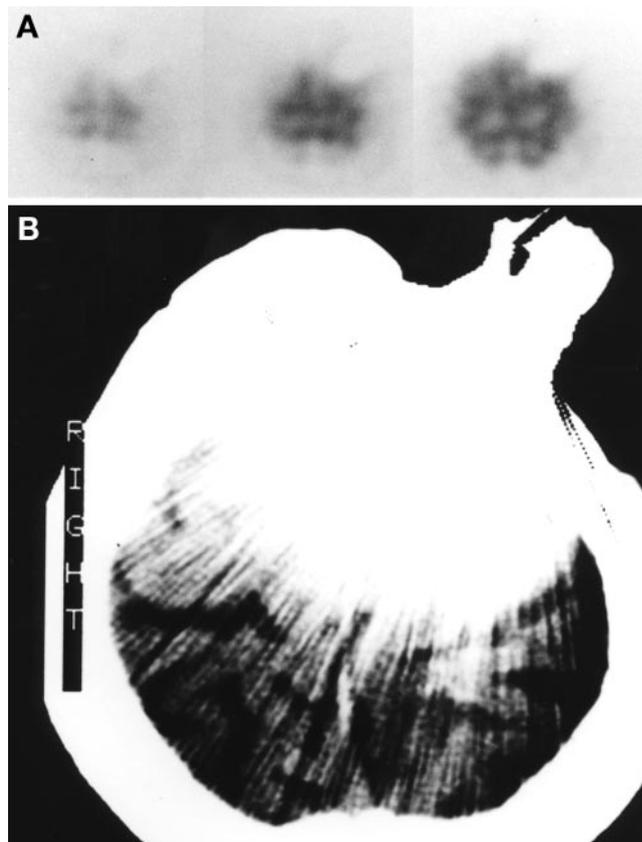
**FIGURE 3.** Patient 3, with head trauma in the 1940s that required a metallic plate in the left frontal area. (A) Transaxial images from brain SPECT study show photon-deficient area in the left frontal region with very faint increased tracer activity extending into scalp area at periphery. (B) CT shows significant streak artifact caused by the metallic plate.

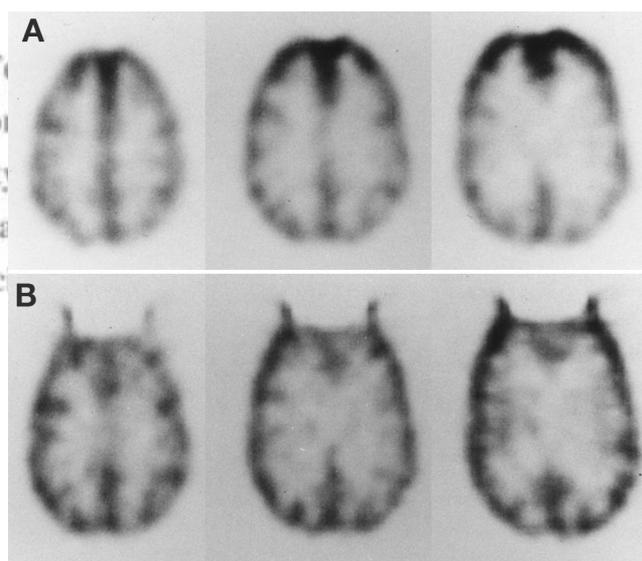
**FIGURE 4.** Transaxial images of SPECT brain phantom with no metallic sheets in place (A) and with 0.076-cm lead sheet placed over midline of the frontal region (B). The 0.038-cm lead sheet produced a similar artifact, though not as prominent.

ible photon-deficient areas and were comparable to the phantom study without any metallic sheets (Fig. 4A). The phantom studies with the lead sheet in place (Fig. 4B) demonstrated a photon-deficient area in the phantom underlying the area where the lead sheet was placed. There was also an increased tracer activity artifact at the periphery of the photon-deficient area that extended into the area where the scalp would be.
